Reinforcement of a Pipeline Right-of-Way in Eastern Kentucky: A Case Study

Yao Zhang, Ph.D., P.E., M.ASCE¹; Benjamin Taylor, P.E., M.ASCE²;
and Yazen Khasawneh, Ph.D., P.E., M.ASCE³

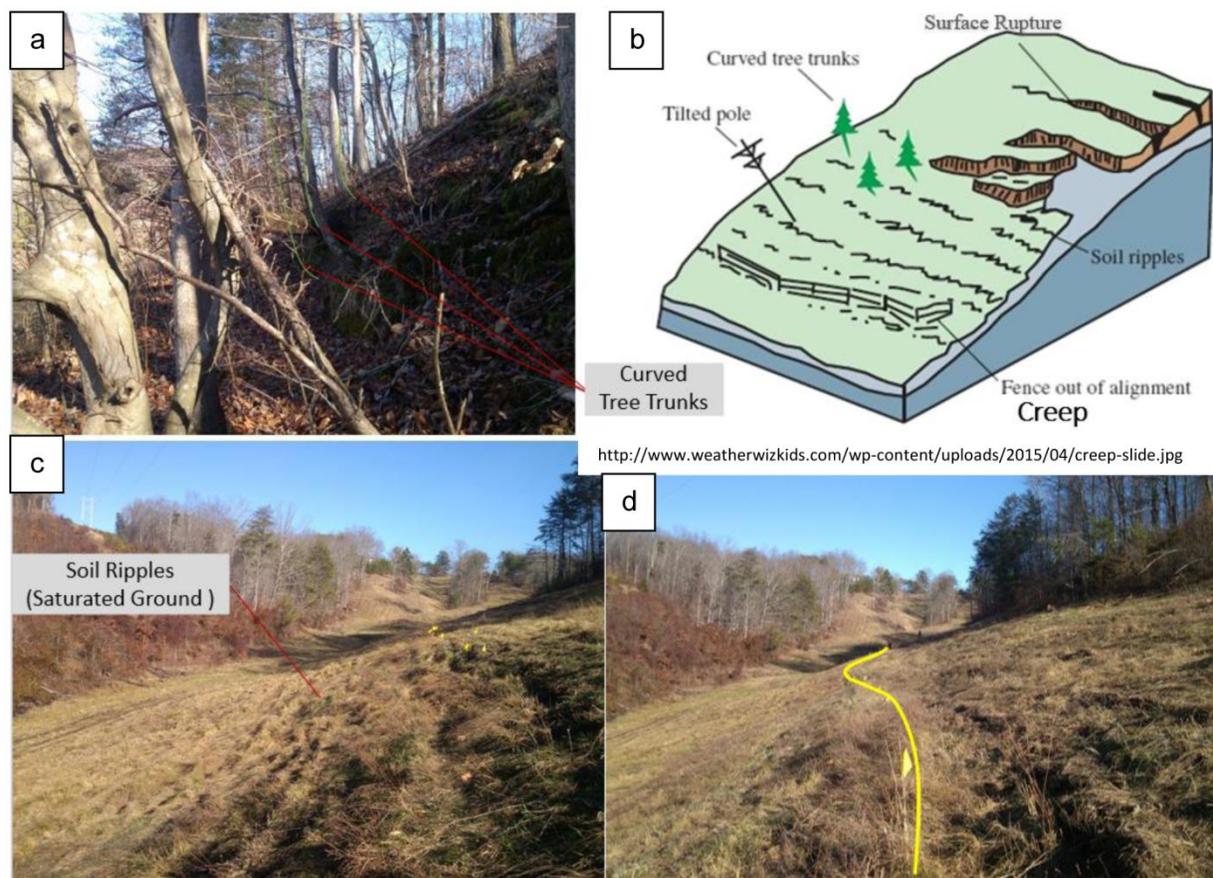
Figure 1. a) Curved tree trunks b) Schematic of creep-type slope movement c) Soil ripples of saturated ground on site d) Impacted pipeline alignment

The landslide site in eastern Kentucky was initially indicated to the natural gas pipeline personnel by a report of potential bending strain based on an analysis of in-line inspection data. In December 2012, a visual site assessment was conducted and creep-type slope movement was observed indicated by undulating (hummocky) ground surface (soil ripples) and curved tree-trunks near the top of the right-of-way. Additionally, a spring located at the top of the slope and an apparent landslide feature was observed near the indicated strain feature location. The marked

pipeline alignment on the ground surface showed a clear curve in the downhill direction over an approximately 150 feet section and the maximum lateral displacement from the original alignment is approximately 14 feet (shown in Figure 1 for general site conditions).

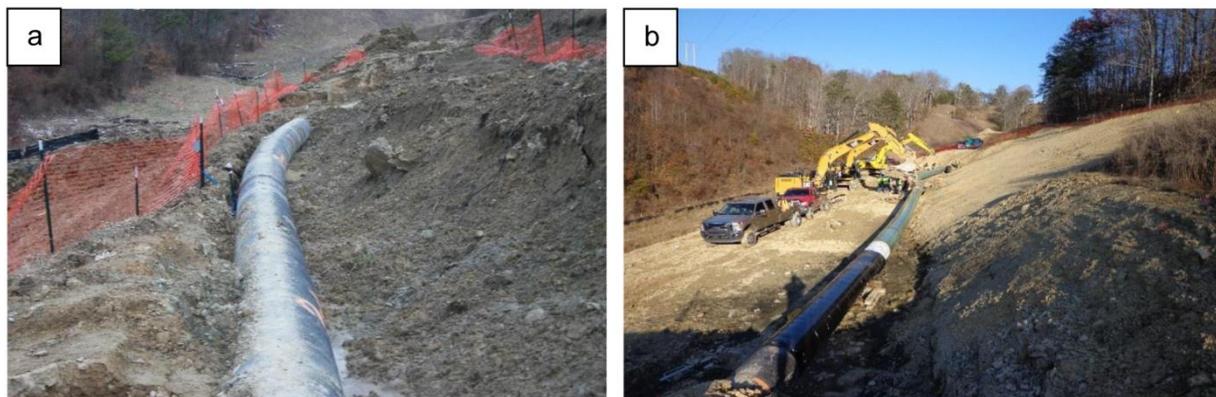
In November and December 2014, a partial pipe replacement was conducted, due to concerns regarding corrosion of the impacted pipeline section at this location (shown in Figure 2). Following the pipe replacement, the trench was backfilled and the slope was graded to provide protective pipe cover and temporarily mitigate ground movement. However, because the reclamation adopted at that time was temporary, the backfill was placed without compaction testing and the fill was not moisture conditioned or benched into the slope. The creep type of ground movement was still observed after the temporary reclamation. In the spring of 2015, the gas pipeline company sought slope reinforcement recommendations to permanently solve the problem. A geotechnical study of the slope and instrumentation monitoring were conducted during the year of 2015, and in-place stabilization option using steel plate pile system was eventually selected by the owner.

Figure 2. a) Exposed Old Curved Pipe 2) New Pipe Installation

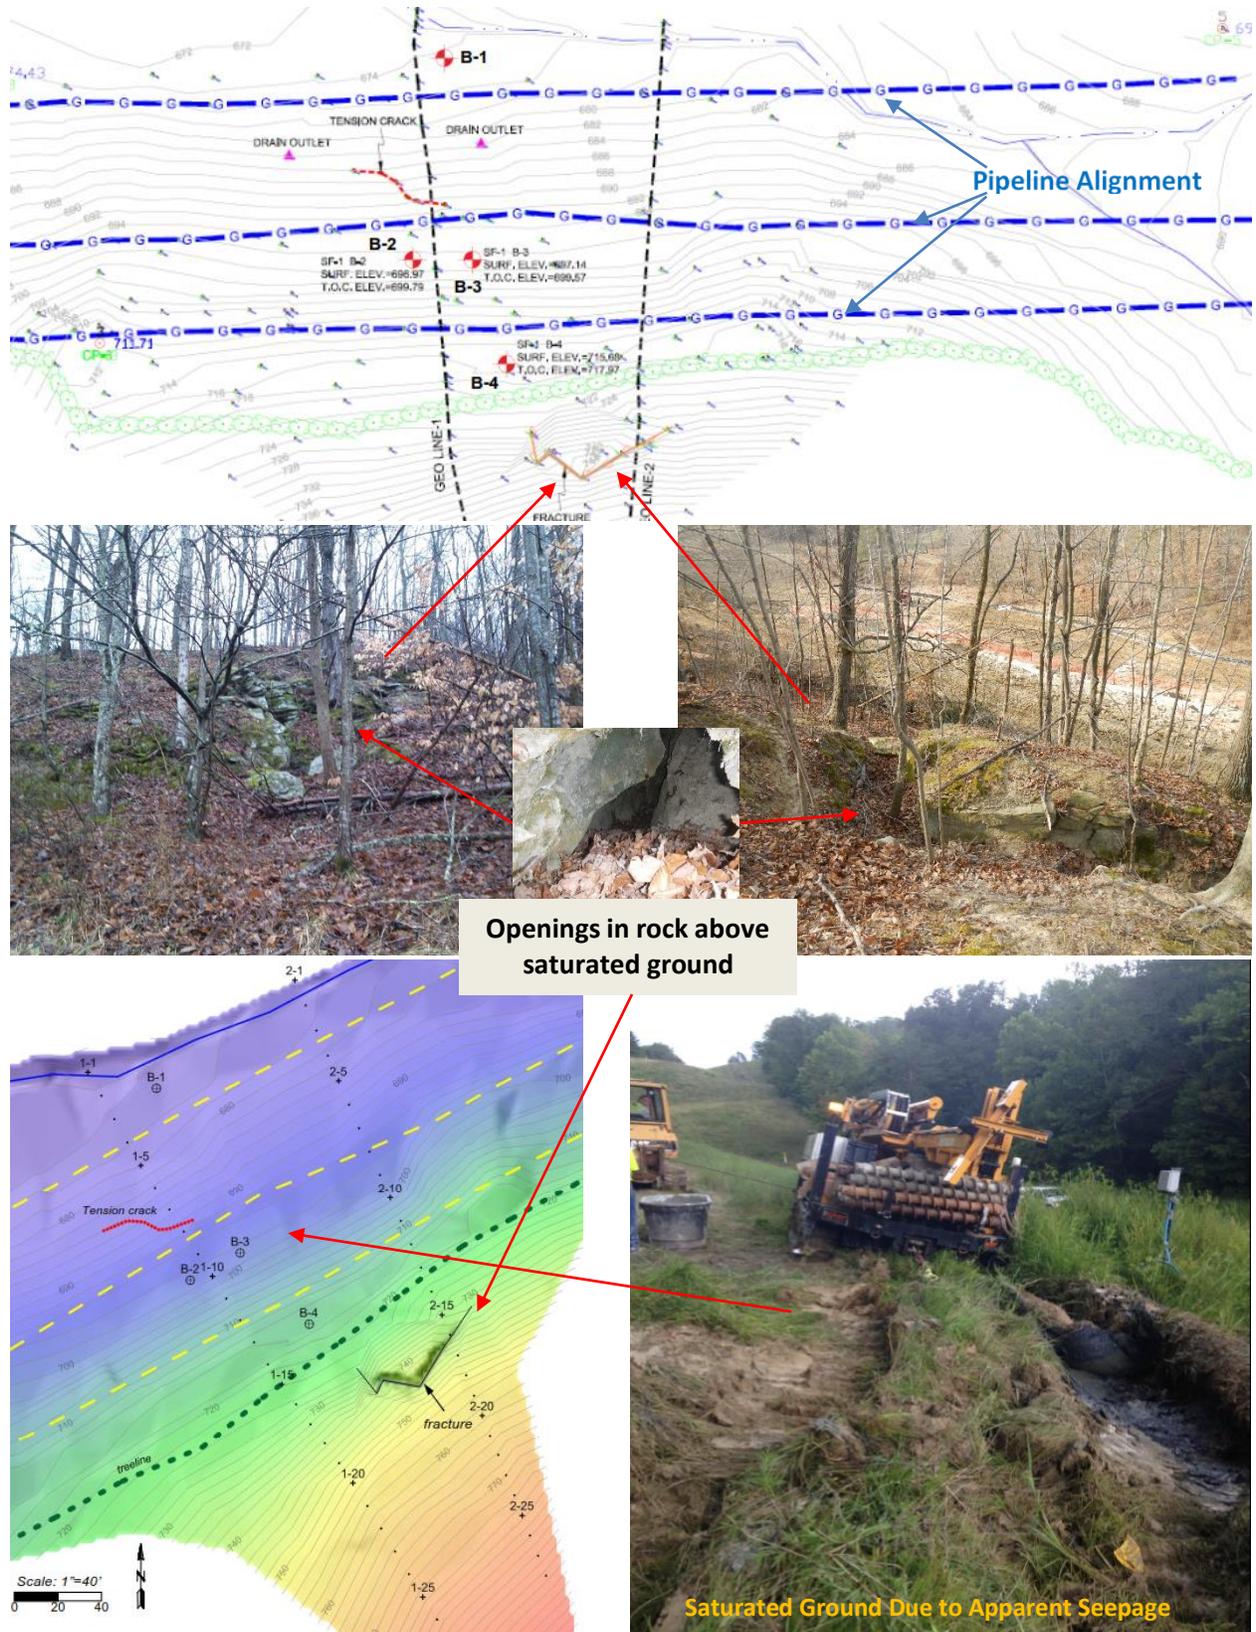
There are three pipelines running parallel within the right-of-way in the strike direction of the referenced slope. The one on the middle slope was the one impacted by the slope movement, experienced bending/strain features and was partially replaced in 2014. Saturated and soft ground with ponding water was observed over approximately 100 feet on the slope slightly above the middle pipeline alignment in the location where most slope movement was observed and the pipeline was curved towards downslope. Apparent spring water or underground seepage appear to be the cause of the soil saturation. During a walk on the upper slope outside the

Figure 3. General Slope Conditions

right-of-way in the wooded area, a natural fractured gap of approximately 10 feet tall and 3 feet wide was observed into the rock (Figure 3). The opening is located approximately 120 feet away and above the saturated location in the right-of-way. The cut of sheet flow by the observed opening/fractured gap and inlet of water could be the source of underground seepage to the right-of-way (Figure 3).

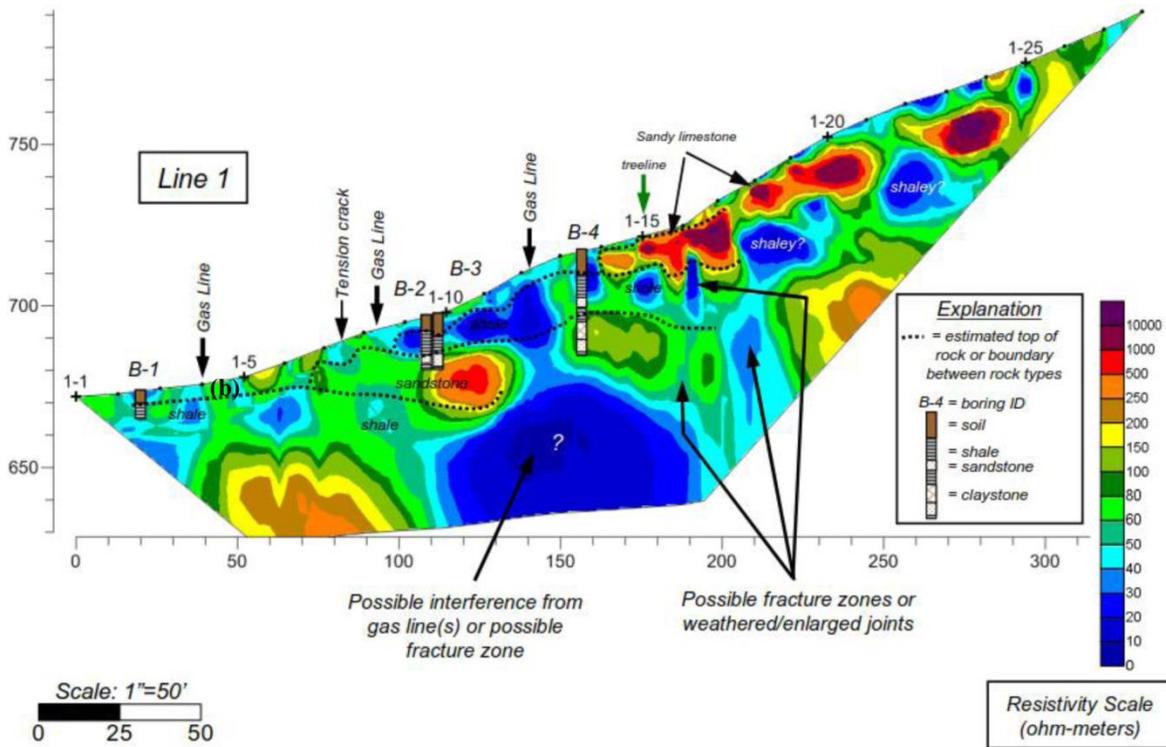
Figure 4. ERI test results

The ERI tests taking into consideration the boring information resulted in two cross-sections of the referenced slope (Figure 4). Based on the test Line 2 which intersect the saturated zone in the right-of-way and the observed opening in rock face on the upper slope, it appears that

fractured rock zone exists beneath these areas and water collected from the opening can be migrating through the fractures and seeping out into the right-of-way.

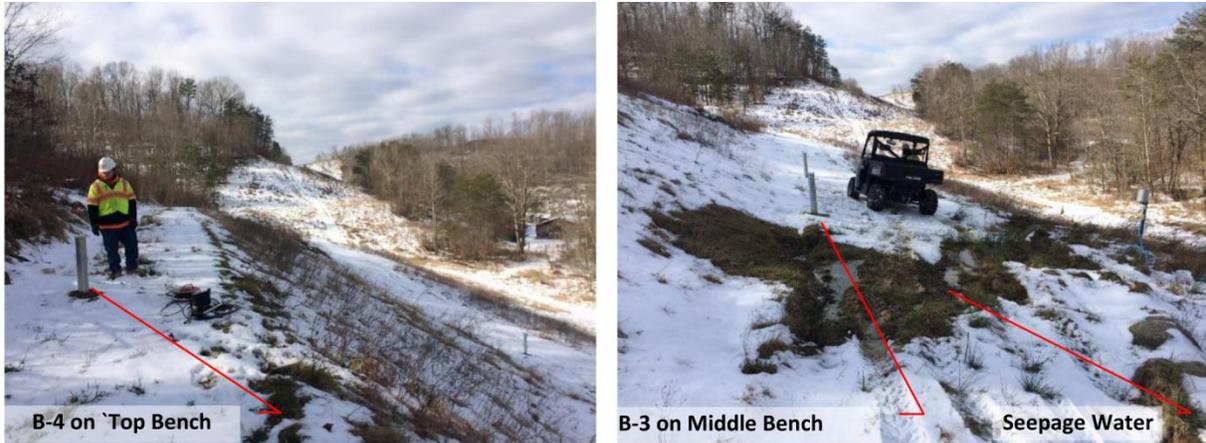
Figure 5. Inclinometer Locations and Its Surrounding Slope Conditions

The slope was monitored using the three installed inclinometers from August 24, 2015 to April 27, 2016. The site photos of the inclinometer locations and their surrounding slope conditions are shown in Figure 5. Water can be observed seeping out of the ground in adjacent to inclinometer B-3 and above the curved pipe section. Based on interpretation of inclinometer monitoring results, the following assessments have been made:

- Inclinometer at B-2: A peak ground surface movement of approximately 0.25 inches was detected at a depth of 6 feet below ground surface, which is at the interface of existing fill material and underlying clayey shale bedrock.
- Inclinometer at B-3: A peak ground surface movement of approximately 0.25 inches was detected at a depth of 4 feet below ground surface, which is within the existing fill material.
- Inclinometer at B-4: No clearly defined zones of movement or failure surface was detected at this inclinometer location.

On-going ground movement is indicated by tension cracking observed at the lower side of the middle bench and inclinometer monitoring data. The observed ground movement was expected based on the temporary nature of the reclamation performed following the pipe replacement project in 2014 and is likely due to the uncontrolled backfill, poor drainage, and fluctuations in groundwater levels along the soil-bedrock interface.

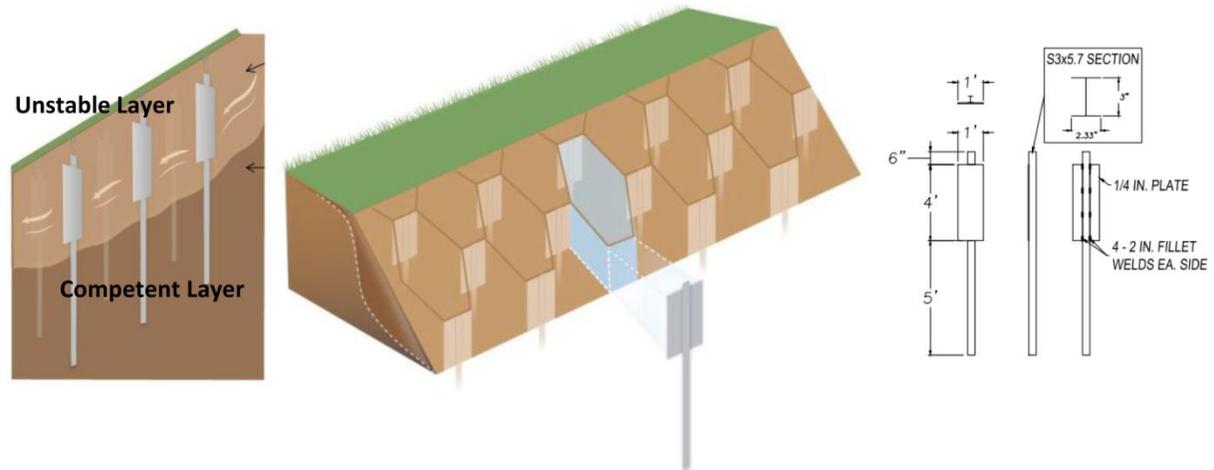
Figure 7. Repair Concept and Pile Dimensions (Geopier SRT)

Lateral resistance piles are typically installed on slopes to intercept the slope failure surface and stabilize the slope by pinning the unstable materials to more competent underlying layers. The system uses driven vertical steel “plate piles” as lateral-reinforcing elements. The plate piles consist of steel angles to which rectangular plates are welded. They are typically installed in a staggered grid pattern using impact or vibratory hammers. Plate piles mobilize the strength of the soil through arching and transmit forces to the underlying stiffer soil or bedrock. The Slope Reinforcement Technology (SRT) repair concept is shown in Figure 7.

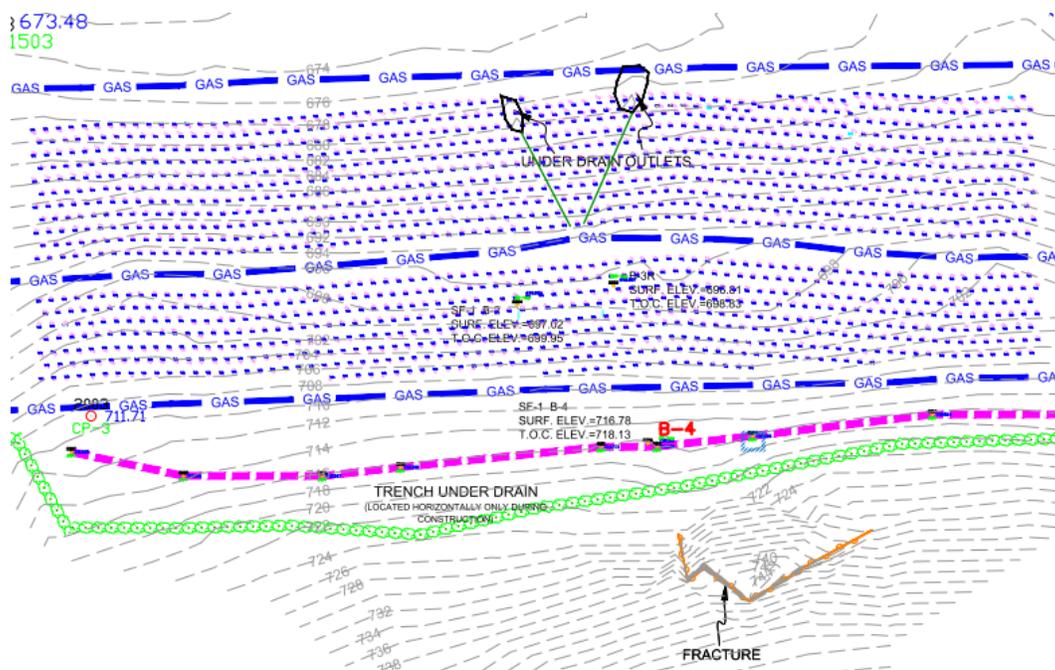
Figure 8. inclinometer Locations and Its Surrounding Slope Conditions

The plate pile used was S3x5.7 steel section that was 9.5 feet in length and installed with the pile top being 12-18 inches below final grade. The plate piles were designed based on a 4.5-foot spacing in the up-slope direction and a 4-foot spacing center-to-center in the horizontal direction. Based on the site condition that bedrock is relatively shallow at around 10 feet below surface, slightly oversize pre-drilled holes were performed for plate pile installation and grouted to ensure penetrating into the underlying bedrock. An approximate area of 85 feet by 310 feet (26,250 ft²) of slope was decided to be reinforced and a total of 1,440 plate piles were installed. As requested by the gas line company, the piles were not installed within 5 feet of the pipeline alignment. The installed pile locations are shown in pink in Figure 8. All plate piles were installed within three weeks and construction completed in six weeks.

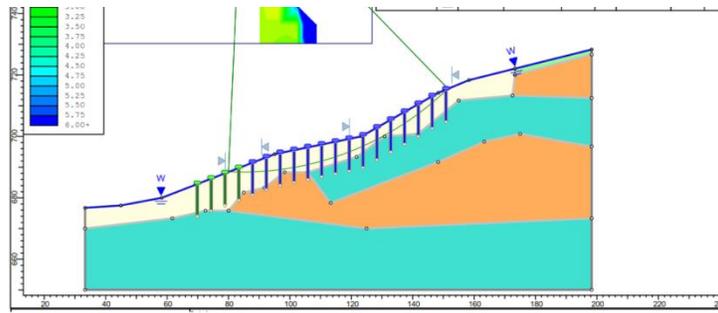
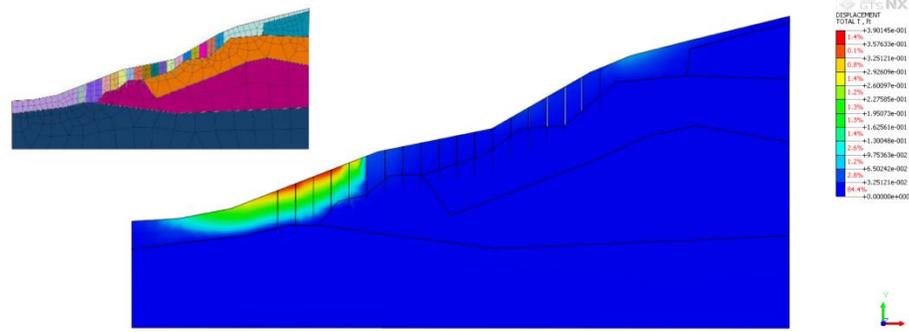
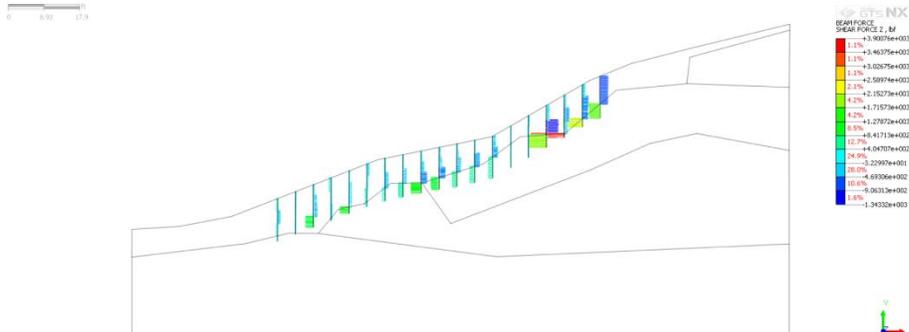
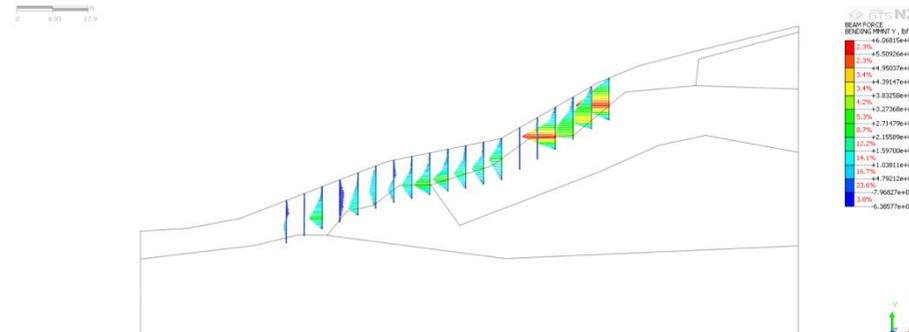
Figure 9. Slope Stability Analysis

(a) Slope Stability Analysis (limit equilibrium)

(b) Total Displacement Plot (FEM)

(c) Shear Force on the SRT Plate Piles (FEM)

(d) Bending Moment on the SRT Plate Piles (FEM)

For this case history study, a finite element analysis was performed to compare the results. The Analysis plots are shown in Figure 9 and the results of the analyses are compared in Table 4.

Comparing to the design analysis performed using LPILE and SLIDE, the FEM analysis results show larger maximum forces on the plate piles and larger deflections on the pile head. However, the maximum forces are still within the capacity of the piles. The FEM analysis also gives higher factor of safety for the slope based on the strength reduction method. Based on this case, the strength reduction method used in finite element analysis appears to result higher loading on the structural elements, which may push the design to too conservative.

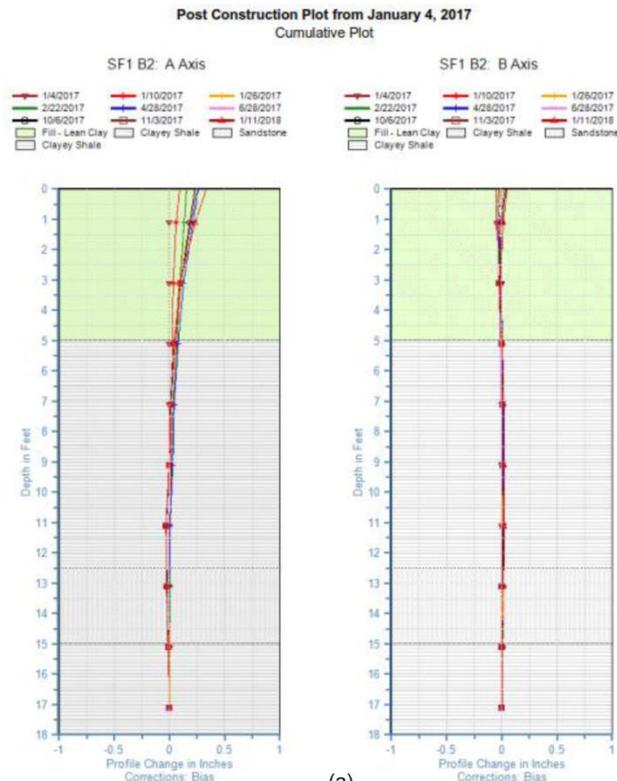
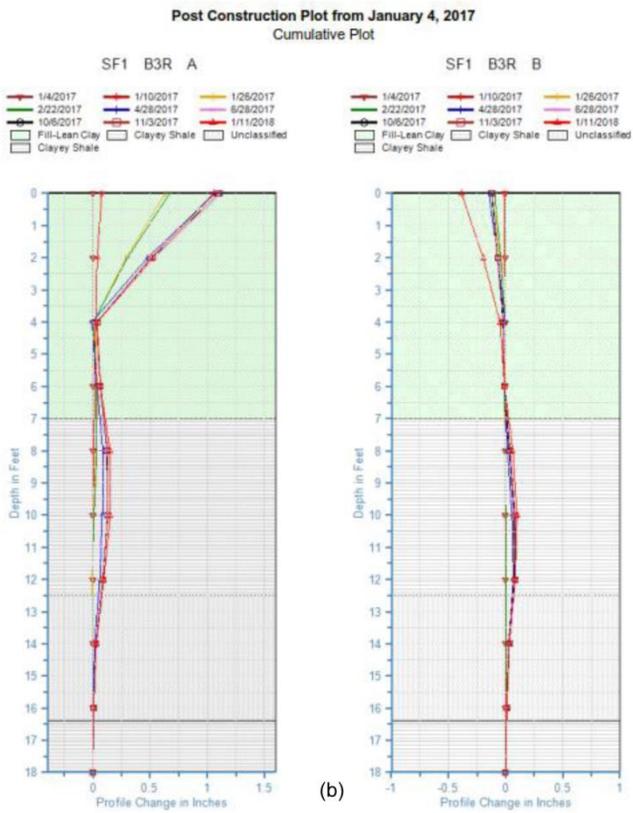
Figure 10. Inclinometer Monitoring Results a) Inclinometer B-2 b) Inclinometer B-3R

The reinforced slope was monitored using the installed inclinometers for a one-year period from January 4, 2017 to January 11, 2018. The inclinometer reading plots for B-2 and B-3R (a replacement of inclinometer B-3 which was damaged during construction) are shown in Figure 10. Based on interpretation of inclinometer monitoring results, the following assessments have been made:

- **Inclinometer at B-2:** A gradual surface movement was recorded after construction being completed. A total surface movement of a magnitude of 0.3 inches can be observed on the plot during the 1-year monitoring period. The movement appeared to be along the soil

bedrock interface at around 5 feet below ground surface. The rate of movement is relatively slow and the movement appeared to be stopped after April 2017.

- **Inclinometer at B-3R:** During the 1-year monitoring period, a total surface movement of a magnitude of 1.1 inches was recorded, in which approximately 0.6 inches of movement was detected within the first 3 weeks after construction from January 4, 2017 to January 26, 2017. After that, an approximately 0.5 inches of movement was detected from February 22, 2017 to April 28, 2017, with a relatively lower movement rate. The movement appeared to be at about 3-4 feet below grade within the lean clay fill layer. The movement appeared to be stopped after April 2017.

The inclinometer monitoring results show that after about four months, the installed steel plate piles appear to be fully engaged and the slope movement was stopped. The amount of recorded surface movement was slightly larger than the design criteria 0.75 inches, but the convergence of the movement generally indicated the well-functioning of the elements. Water was observed in the drainage outlet, which means the drainage system installed on site was also functioning (shown in Figure 11).

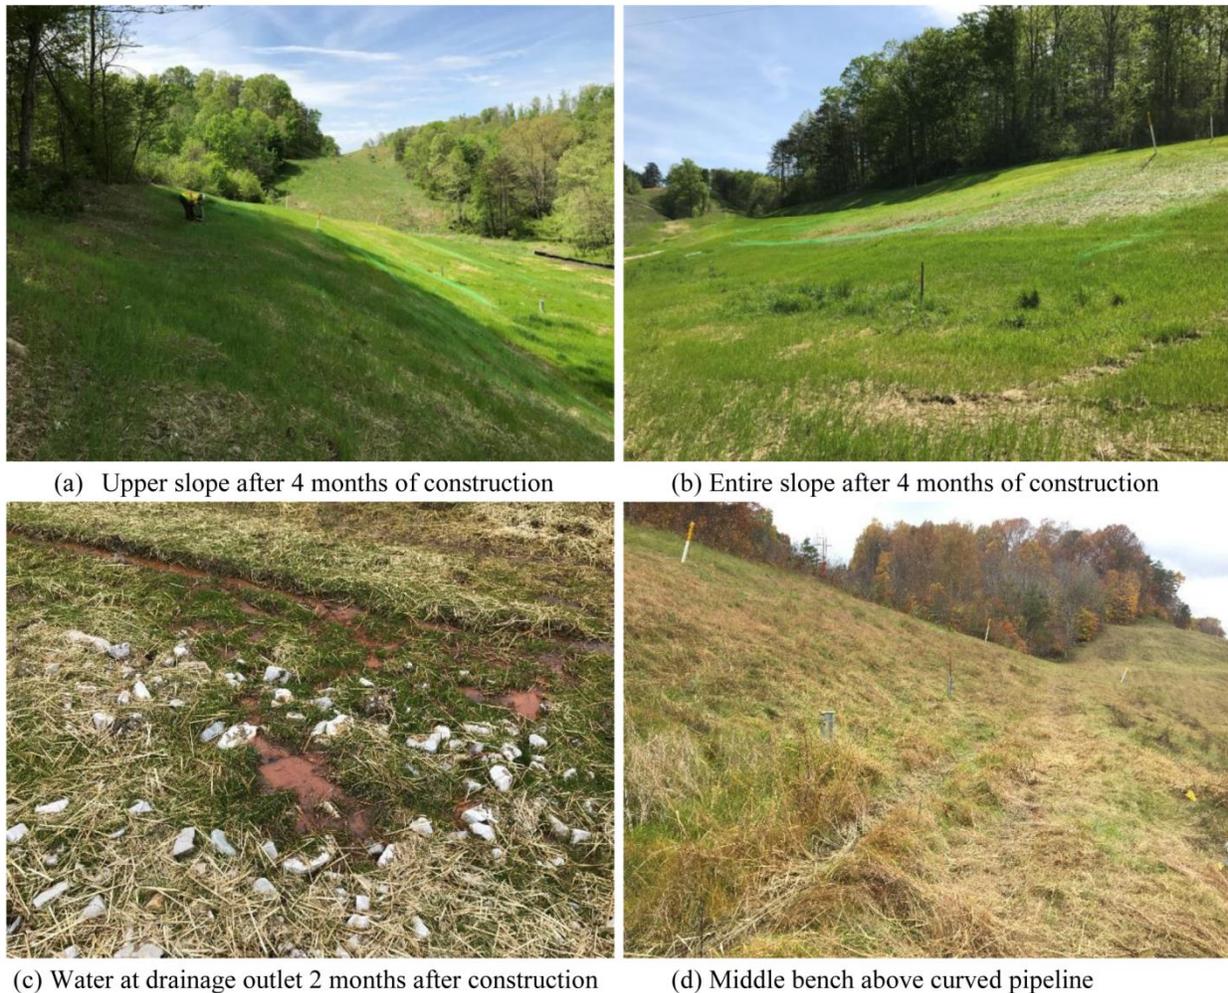
Figure 11. Inclinometer Locations and Its Surrounding Slope Conditions

To address the underground seepage issues of the slope, drainage improvement was designed and installed on the slope as well. To capture the potential seepage from upper slope, a trench drain down to bedrock (approximately 10 feet) was installed along the tree line above the right-of-way. To quickly drain the water trapped in the saturated zone and relieve the water pressures, two finger drains were installed on the down-slope side of the saturated zone and curved pipe location.
