DEVIATIONS FROM DESIGN IMPACT PERFORMANCE OF AN AGGREGATE PIER SUPPORTED EMBANKMENT

Jay L. Hodkinson , GZA GeoEnvironmental, Inc., Manchester, NH, USA
James R. Wheeler, Design/Build Geotechnical, LLC, Marlborough, MA, USA
Christopher C. Benda, Vermont Agency of Transportation, Montpelier, VT, USA

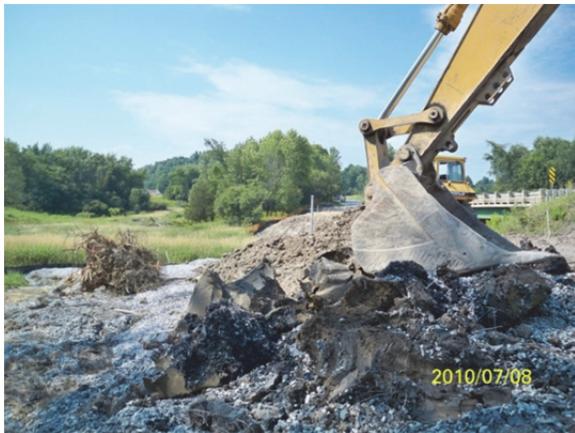
Figure 5 – “Controlled” Placement of Clay Fill

The embankment fill was placed rapidly with limited field inspection and no compaction testing or laboratory testing. However, the geotechnical design consultant was not made aware of the fill operations until July 12, 2010, when the first instrumentation report was submitted indicating elevated pore pressures (approximately 10 ft (3 m) of water head). In addition, inclinometer data were not available at the time since INC-1 had not been replaced after being damaged during RAP installation. The first data obtained at inclinometer INC-1 were not available until July 23, 2010 and these data indicated a lateral displacement of approximately 4 in (102 mm) to the west at a depth of 16 ft (4.9 m) below ground surface. See Figure 6.

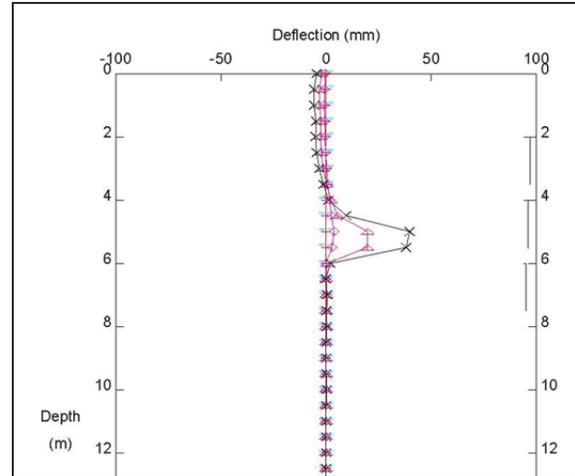
Figure 6 – INC-01 Deflection Results on 7/23/10

The project team immediately requested that fill operations be stopped until instrumentation readings stabilize. However, the embankment fill operations had already been completed for three days.

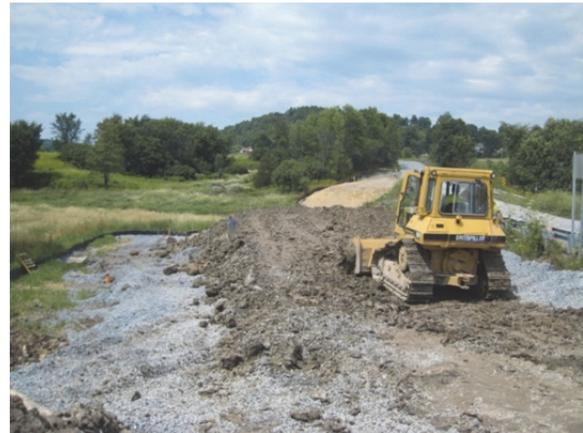
and the RAP submittal developed by the specialty subcontractor, the approach embankment was to be constructed with compacted granular fill. However, with the exception of an initial lift of sand fill, the contractor had constructed the embankment with loosely compacted clay fill (see Figure 7).

Figure 7 – The Clay Fill was only compacted during placement with a Dozer.

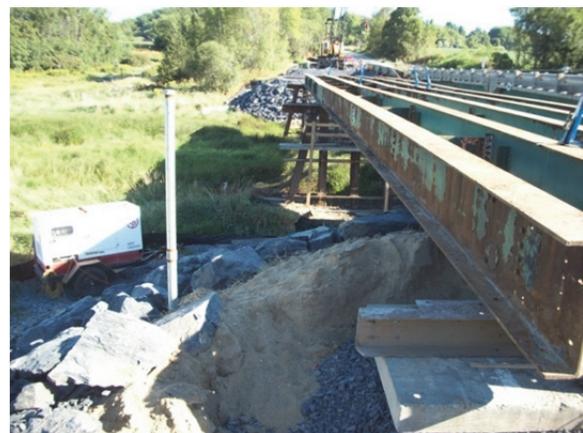
The second major discrepancy was the assumption that the temporary bridge south abutment would be pile supported. However, the general contractor constructed a 3-span temporary bridge that incorporated two pile-supported intermediate piers and abutments supported on spread footing foundations bearing at the top of the approach embankments as shown in Figure 8. This significant discrepancy was not realized until the contractor had submitted the bridge design *after* the bridge had been constructed.

Figure 8 – Abutment Bearing at Top of Embankment.

To increase the embankment's global stability factor and limit further lateral deflection, the geotechnical consultant recommended that the bridge abutment pressures be reduced. To achieve this, the general contractor would have to underpin the abutment foundation with micropiles or some other deep foundation system. A counter berm was also recommended as another mitigation alternative. However, due to wetland encroachment restrictions this was not a feasible measure. The contractor chose to accelerate permanent bridge construction rather than implement mitigation measures.

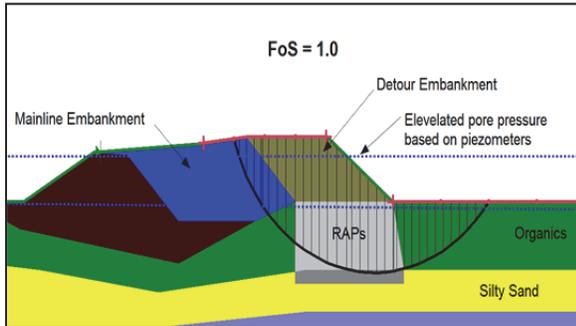
Figure 9 – Stability Results Based on Elevated Pore Pressures

- The area showing the most movement is the southern abutment side slope. This was consistent with instrumentation obtained data to date.
- The initial lateral movement observed in INC-1 may be attributed to increased pore pressure developed during RAP installation followed by the immediate, rapid embankment filling.
- The lateral movement was then exacerbated by the subsequent application of unanticipated abutment loads from the detour bridge.

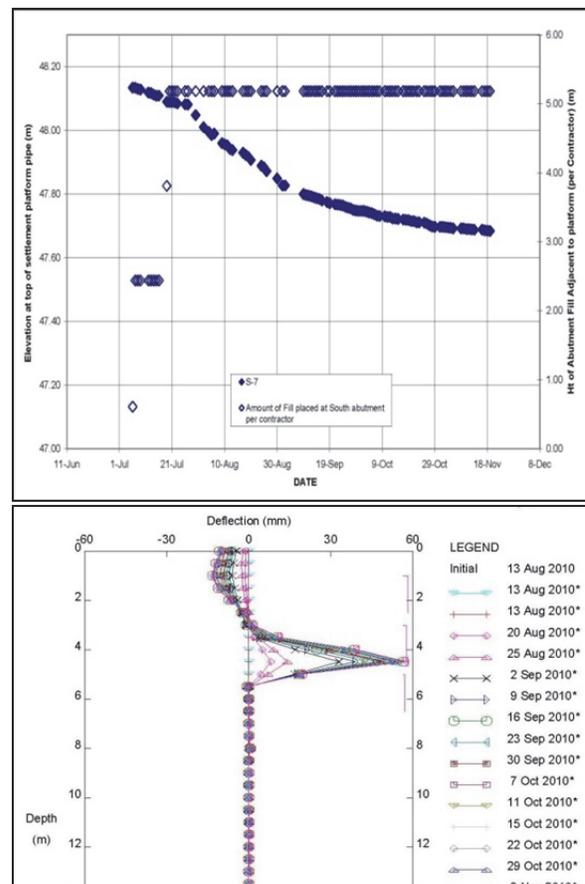
Although the general contractor's original plan was to complete the new bridge prior to winter shutdown, it was not going to be opened to traffic until spring when the approaches and paving would be complete. As a result of the concerns for public safety, the Agency had the general contractor accelerate the completion of the approaches to the bridge and place temporary pavement on the bridge deck so that the detour did not need to be maintained over the winter months. The detour embankment was monitored on a full time basis for safety reasons until the general contractor was able to open the permanent bridge. November 23, 2010, the permanent bridge was opened to traffic. November 28, 2010, the temporary bridge and detour embankments were removed. The total settlement for the south detour abutment area was 17.7 in (450 mm). The total lateral displacement in the same area was approximately 13 in (330 mm). See Figure 10.

Figure 10 – Settlement and Inclinometer (Partial Plot) Results
