# Trunk Highway 67 Slope Repair, Yellow Medicine County, MN

**ABSTRACT:** A 175 foot long section of Minnesota Trunk Highway 67 embankment experienced a slope stability failure in 2010; while there was existing distress at the site, it is likely that heavy September rainfall accelerated existing distress or promoted new adjacent instability. This highway section was along Hazel Creek, approximately 4 miles south of Granite Falls. A rapid response was needed to restore the slope and highway embankment prior to winter. Use of a column supported embankment (CSE) was considered the best option to provide strength and base support for a new roadway embankment. This approach was designed and specified as an “Aggregate Column Supported Embankment Stabilization System” (ACSESS). MnDOT also designed a Reinforced Soil Slope (RSS) with drainage and base riprap to complete the embankment repair and slope protection. Ground Improvement Engineering (GIE) designed the ACSESS system to increase the composite shear resistance and control settlement beneath the RSS. This was the first application of the Rammed Aggregate Pier® system by the Minnesota Department of Transportation (MnDOT). The paper d

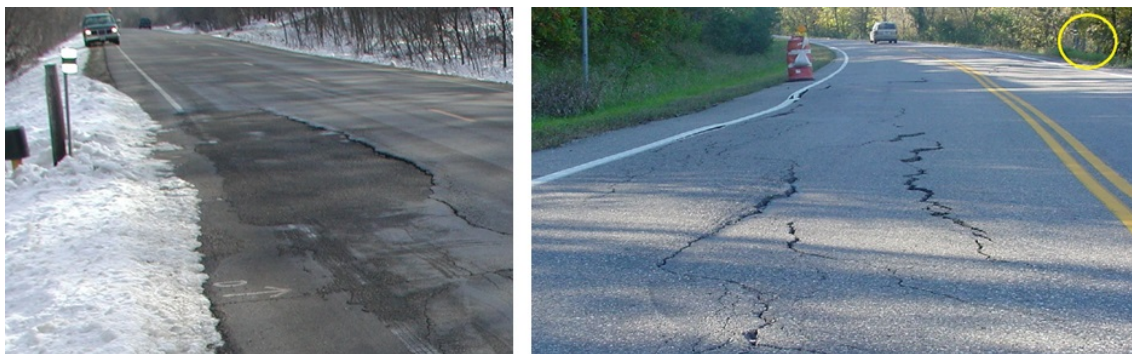
Southwestern Minnesota and the Granite Falls area were subjected to 3 to 8 inches of heavy rain and local flooding on September 23, 2010. Following this event, larger and more significant roadway distress and down-slope embankment scarping developed along a larger section of roadway further southeast and adjacent to Hazel Creek. This new distress now impacted the entire roadway, for a linear distance of about 175 feet and was characterized by multiple areas of subsidence and cracks in several groups as shown in the right photo of Figure 1.

Figure 1. The roadway asphalt was patched sometime prior to January of 2007 (left). The 2010 distress, (right), propagated across the entire MN 67 roadway. The T-100 inclinometer installation [at left in the left photo] can be seen in the upper right of the right photo [yellow circle] taken from the other direction.

Settlement of more than 6 inches overall was seen in the pavement. Several large progressive failure scarps in the slope adjacent to the creek were observed through the brush covering the

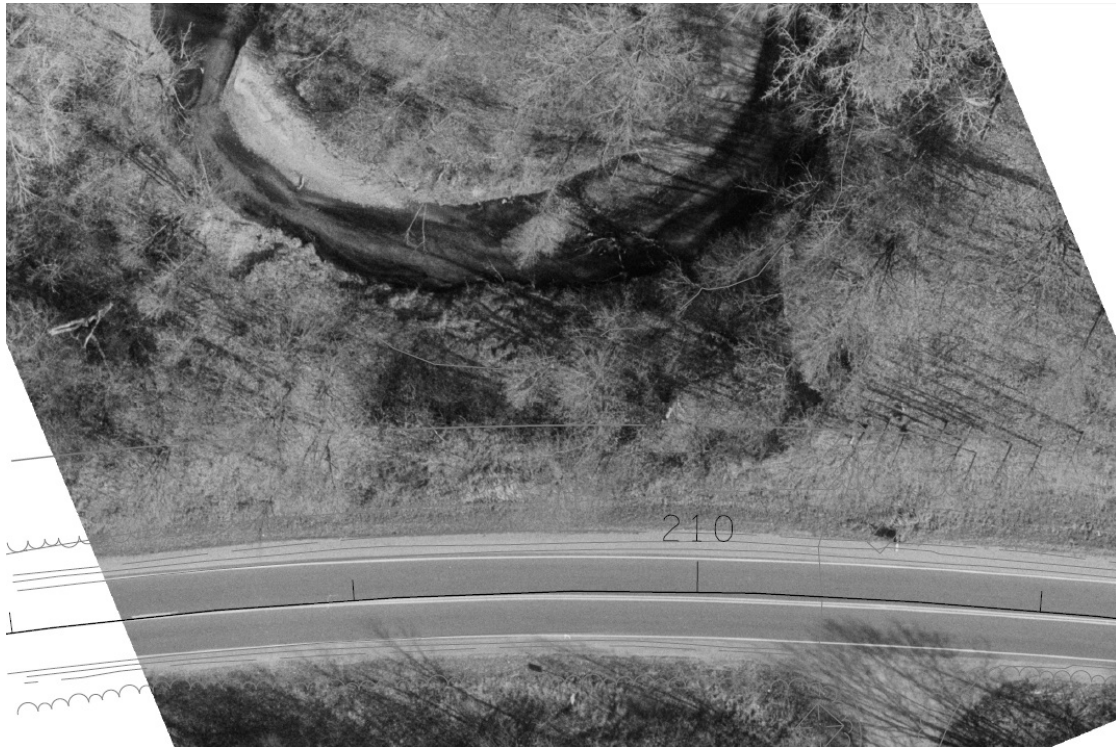
slope. The new and more significant scarps and roadway distress appeared to be promoted or triggered by the large rain event, although progressive loss-of-ground and streambank erosion at the outside of the bend in Hazel Creek can be seen in a historic aerial photograph, Figure 2.

Figure 2. The north side of the MN 67 highway embankment is adjacent to an outer stream bend of Hazel Creek. Progressive channel erosion on the outside bank of the stream appears to be a contributing factor in the movement observed on inclinometer T-100 [lower left, approximate station 208+75] and the long-term small-scale ongoing pavement distress seen from 1998 to 2010. Significant new movement and roadway distress occurred after a large rain and flood event in September of 2010.

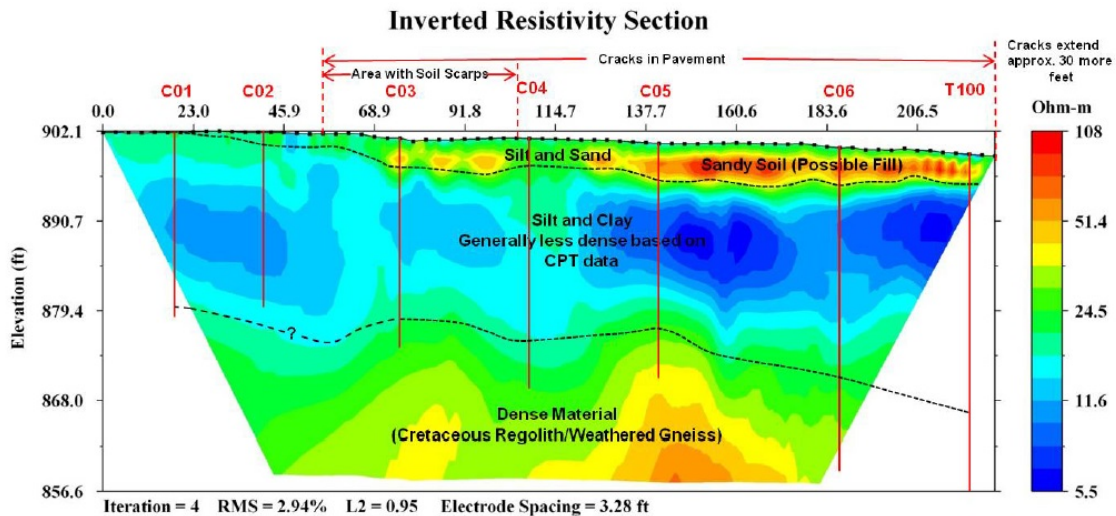
When the asphalt settlement and pavement cracking were observed by maintenance personnel, it was clear that the 2010 distress was significantly larger and more severe than the ongoing settlement nearby. The Foundations Unit scheduled immediate drilling and CPTu investigation. Three lines of CPT soundings were advanced (C01 – C26) and three soil borings were drilled (T110, T111, and T112) to help characterize the site. The MnDOT Geology Unit also conducted a 70 meter 2D Electrical Resistivity geophysical survey along the east shoulder of the roadway starting at the approximate location of T-100 and heading southeast. The resistivity plot showing the generally problematic soils overlying the local bedrock is shown in Figure 3.

Figure 3. The resistivity survey showed weaker soils (in blue) below the roadway embankment.

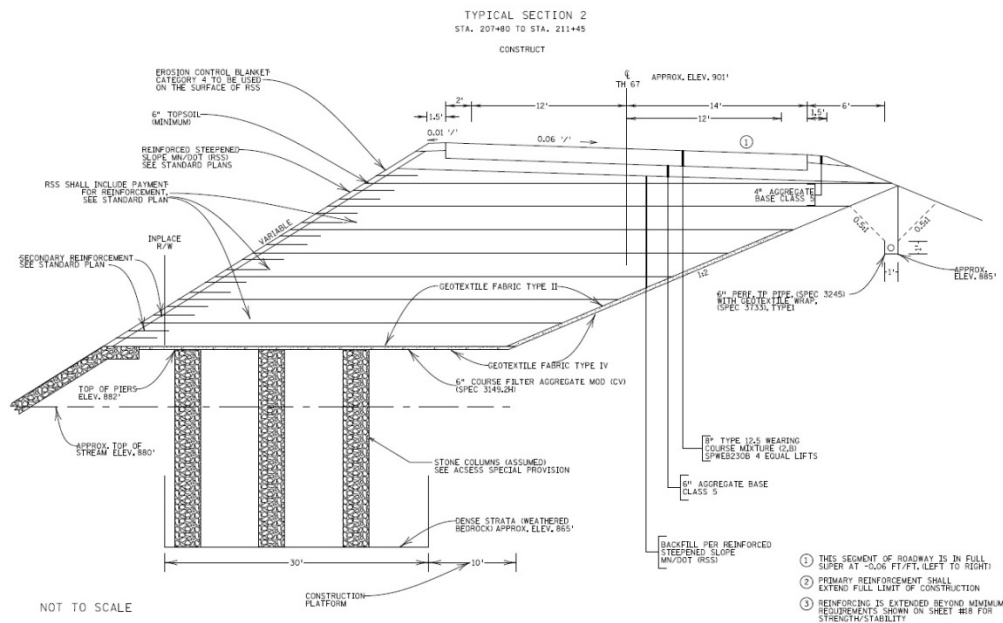
Figure 4. The repair detail showing support columns and reinforced earth area below the new roadway.

The preferred solution evolved from the CSE and RSS options. A CSE system could support a continuously reinforced RSS which would in-turn, support the roadway and buttress up-slope areas. The hybrid system was detailed and specified as a non-proprietary “Aggregate Column Supported Embankment Stabilization System” (ACSESS). The design included additional elements such as a rear drainage blanket, ditch drainage system, roadway and pavement, guardrail, toe erosion protection, and topsoil and seeding for the slope face (Figure 4). To ensure the entire system acted as uniformly as possible, the primary reinforcing elements extended throughout the replaced embankment soils. MnDOT provided the design for the RSS.

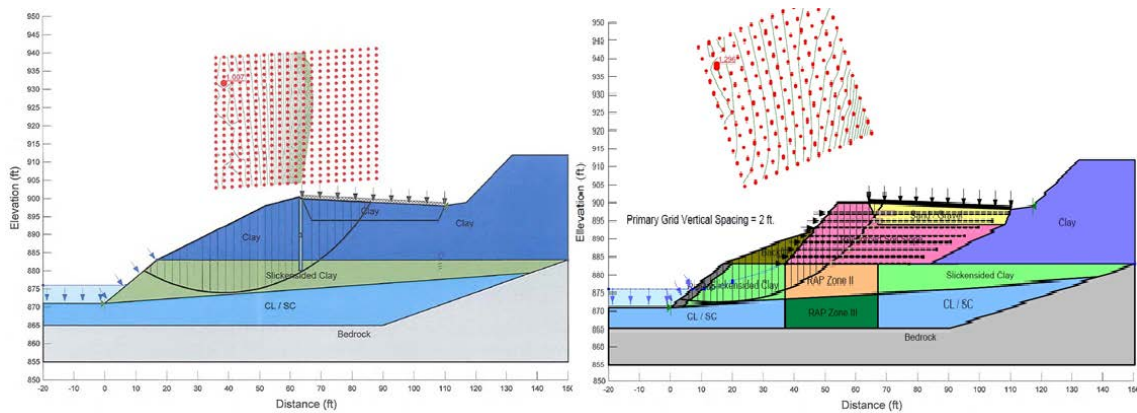
An angle of internal friction of 42° was conservatively used for the aggregate pier elements. The ratio of the soil below the RSS to the area replaced by the RAP,  $R_a$ , was determined using a Geopier spacing of 4.5 ft. on-center and a diameter of 30 in. for each element. The RAP spacing was determined on a trial basis as necessary to achieve a factor of safety against instability of 1.3. This analysis was for failure surfaces that intersected the RAP-reinforced zone. A plot of the FS = 1.0 failure condition and the proposed remediation with FS = 1.3 is shown in Figure 7.

Figure 7. Plots of the Slope/W FS calculations for both back-calculation of the slope properties at imminent failure; FS = 1.0 (left) and the proposed RAP elements and the RSS above (right); FS = 1.3.

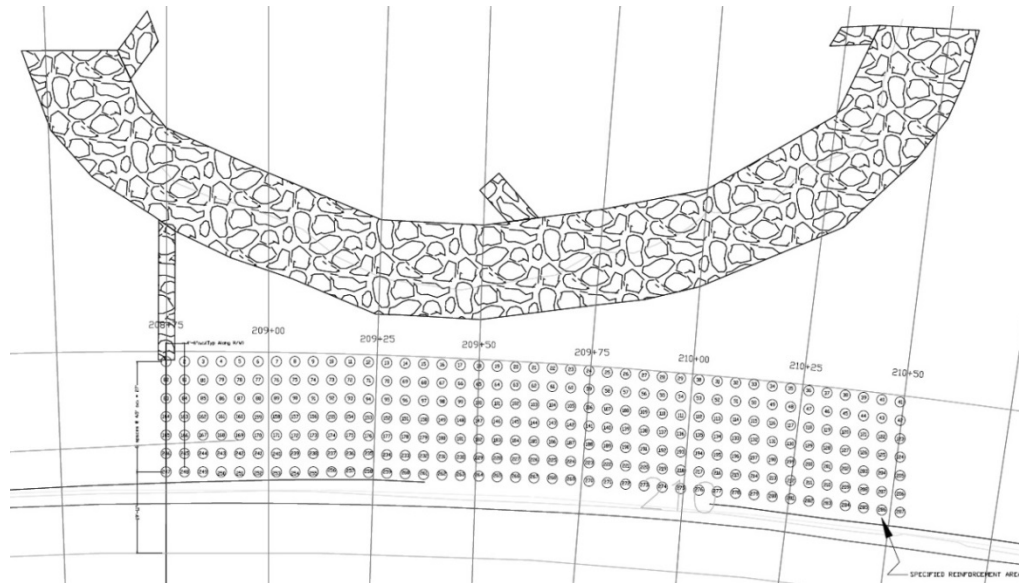
Figure 8. The Geopier layout is shown relative to the stream and the protective slope riprap.

The contractor design used 287 RAP elements in seven rows between roadway stations 208+75 and 210+50. The elements were constructed between November 22 and December 1, 2010. The prime contractor graded a 40 foot wide level work area for equipment access. The installation

grade was established at elevation 882 feet. Each RAP element was 30 inches in diameter and extended to the termination strata (weathered bedrock) between elevations 867 and 861 feet. The aggregate consisted of ¾-inch to 2-inch diameter clean crushed rock for the entire shaft. The RAP element layout is shown in Figure 8.

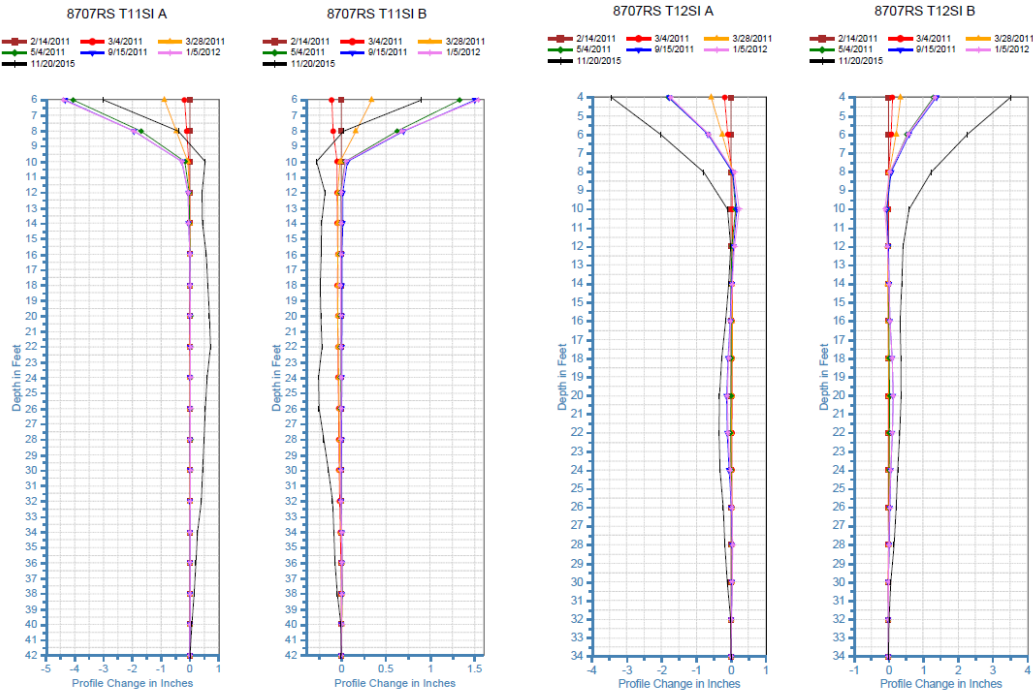
Following the installation of the CSE, as the RSS was being constructed, and just before a snowstorm was predicted, on December 9, 2010, MnDOT advanced two borings downslope and slightly outside on either end of the RSS area and installed inclinometer casing. Traversing-probe inclinometer readings were taken periodically. Limited movement was seen below the RSS. Deep lateral deflections were near zero in the months immediately following CSE/RSS installation and less than one-half inch five years after construction. Larger movements of up to 4 inches in the near surface are believed to be related to frost or shifting of the near-surface channel rip-rap. Inclinometer plots are shown in Figure 9. In 2011, some distress above the roadway was noticed and two ShapeAccelArray sensors were installed in the upper hillside. No deep-

seated movements have been observed; some movement is occurring in the upper hillside, potentially from disturbance and stress relief from project excavation or dewatering.

Figure 9. Inclinometer plots showed movement below the RSS was limited to less than one half inch. The movement seen at the top of the plots is related to tilting of the above-ground protective casing.
