Stabilization of Failing Slopes Using Rammed Aggregate Pier Reinforcing Elements

This paper presents two case histories describing the use of Rammed Aggregate Pier soil reinforcing elements to stabilize slope failures. The analytical methods used in the design solutions are presented along with a description of the construction sequence and post-slide repair, instrumentation, and performance. This paper is of significance because it describes how a simple and cost-effective solution may be effectively implemented to stabilize unstable slopes.

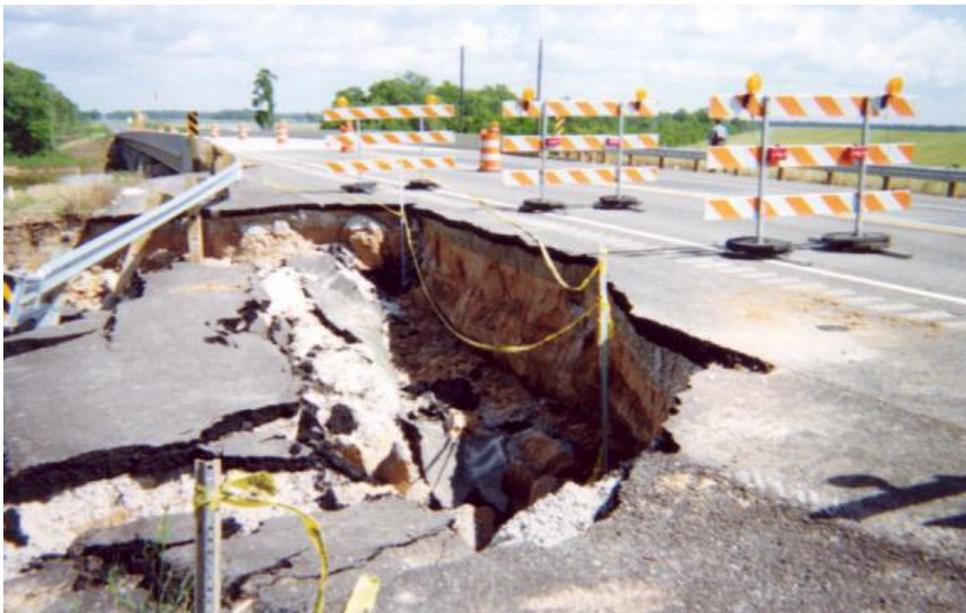
Figure 2- Slope Failure at US-71, Krotz Springs, LA

The southwest embankment of the southeast approach bridge ramp of US Highway 71 over Bayou Des Glaises experienced a recurring slope failure after placement of a new 0.9 m to 1.5 m (3 to 5 foot) high fill embankment as part of the construction of a new replacement bridge. The slope failure produced a 1.2 m (4 foot) high scarp and the failed mass displaced out approximately 3 m to 4.5 m (10 to 15 feet) into the Bayou Des Glaises as shown in Figure 2. The slide caused the Louisiana Department of Transportation to shut the southeast bound lane of the road because of the potential of progressive sloughing towards the centerline of the road.

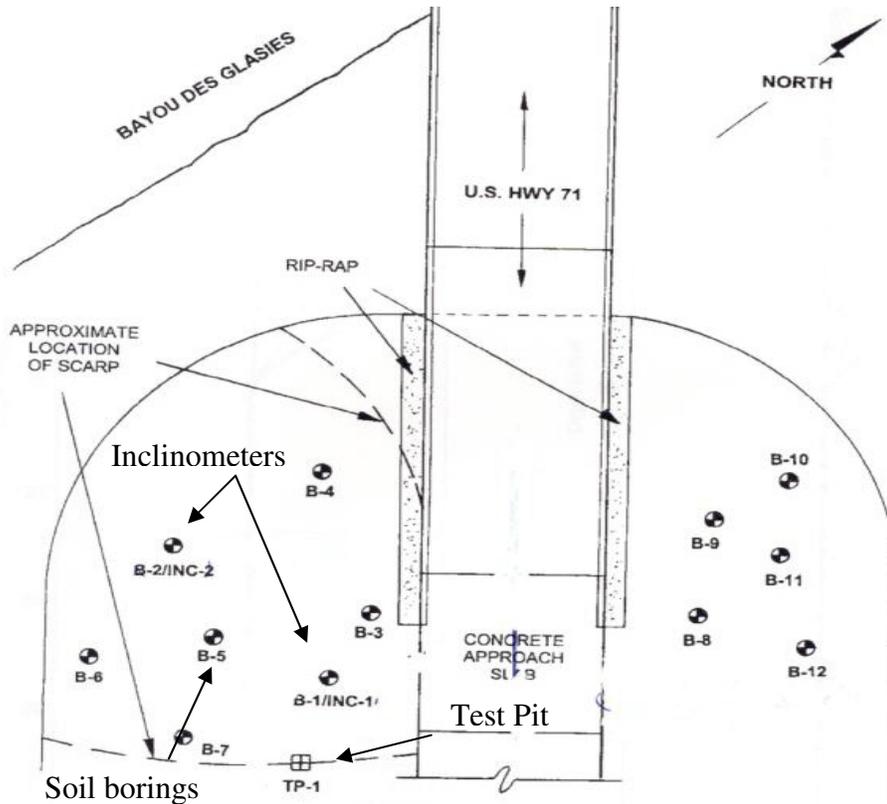
Figure 3- Plan View of Slope Failure and Boring Location/Instrumentation Plan

A geotechnical investigation was performed and pre-stabilization instrumentation was installed by Fugro Consultants LP at the site after the slope failure occurred. The geotechnical investigation included twelve borings and one test pit as shown in Figure 3. Inclined meters were installed at the B-1 and B-2 locations. Fill material consisting of high plasticity clay with silt and organics extending to depths of up to 6 m (20 feet) over soft to medium stiff, high plasticity clay (Bayou Des Glaises) were encountered

within the failed mass area (Figure 4). Static groundwater levels coincided with the slope toe elevation. The post-sliding inclinometer data indicated the failure surface extended into the Bayou clay at depths of 3 to 6 m (10 to 20 feet) below the road level.

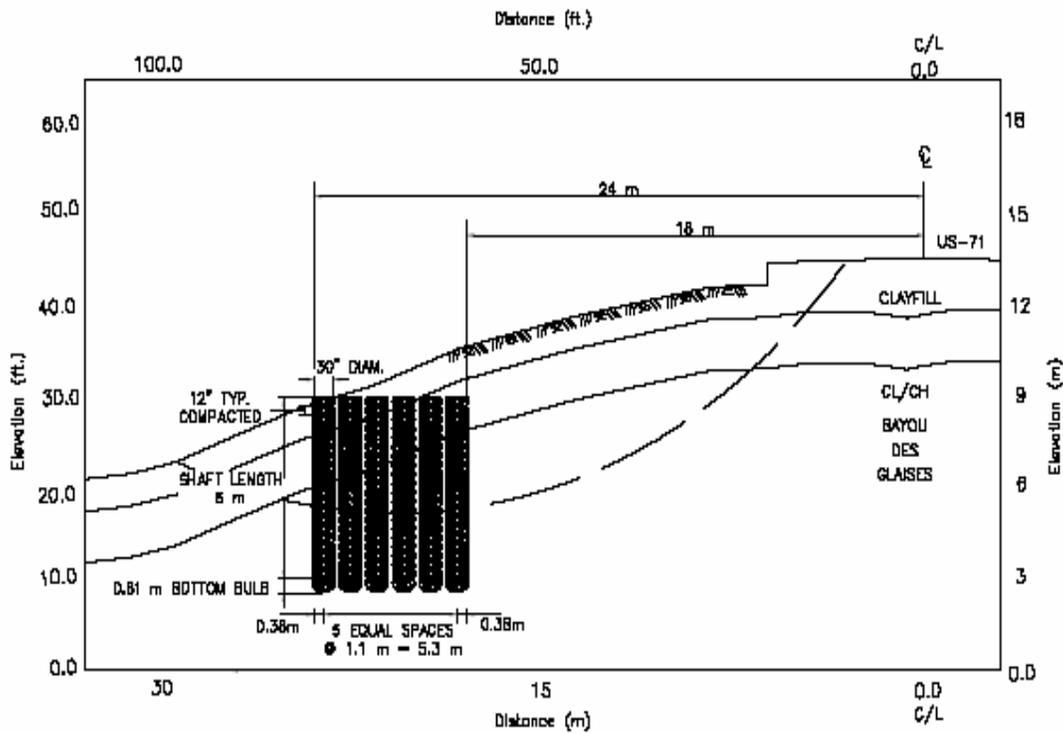
Figure 4- RAP Reinforcement and Stabilization at US-71 Slope Failure.

The RAP stabilization scheme was established on the basis of back analysis of the slope to determine the soil shear strength parameter values and pore pressure conditions that led to slope failure (Factor of Safety = 1.0). Results of the back-analyzed, long-term shear strength parameter values are presented in Table 1 below. Because of the heavy rains that occurred prior to the failure, the pore pressure condition used in the back analyses simulated a fully saturated condition throughout the slope.

After establishing soil parameter values from the back analyses, additional slope stability analyses were performed to determine the RAP area replacement ratio required to increase the factor of safety to the design requirements (FS=1.3 or greater). The results of the additional slope stability analyses indicated the area replacement ratio to achieve the design criteria was 42% within a 6-m (20-foot) wide area of the middle third portion of the slope as shown in Figure 4, resulting in a pier spacing of 1.1 m on-center (3.5 feet on-center). The slope face was graded in the middle portion of the slope by preparing a flat working platform at Elevation 100 m (328 feet) to allow installation of the piers to a depth of 6 meters (20 feet) to completely penetrate through the failed soil mass and critical surface to penetrate into the underlying firm clay. The piers were constructed using clean, open-graded stone to promote drainage and minimize excess pore pressure generation within the surrounding clay matrix soil. Installation of nearly 340 piers occurred in less than 2 weeks without interfering with local traffic. After pier installation the tops of the piers were capped with high plasticity clay to prevent water from infiltrating into the piers, the slope face was regarded, and the road shoulder lost after the slope failure was repaved.

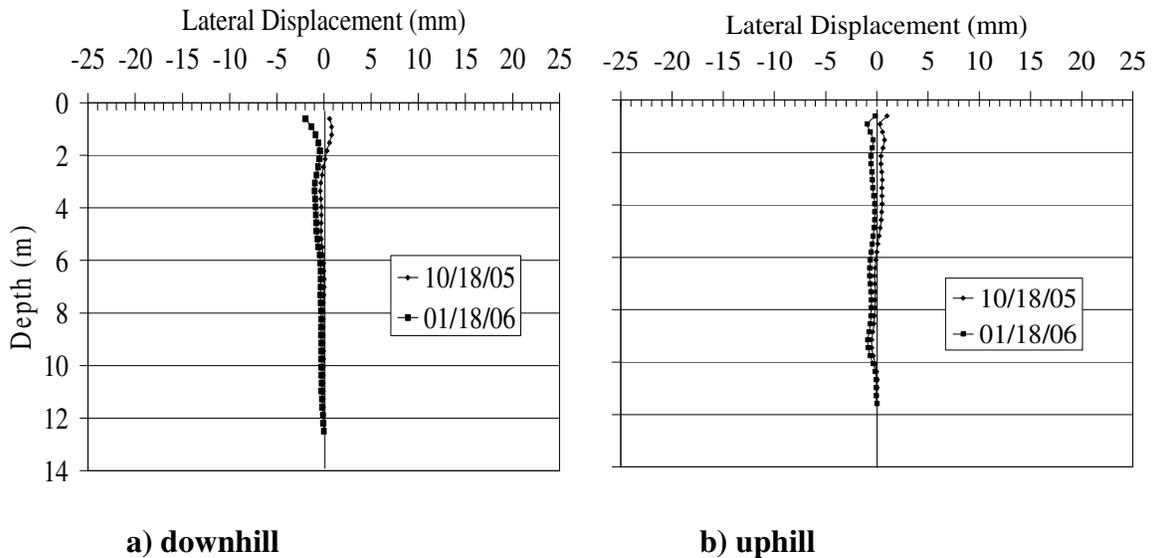
Figure 5- US-71 Slope Repair Lateral Displacement Monitoring Results.

Post-installation lateral displacement monitoring was conducted during a 15-month period after RAP installation. Two vertical inclinometers were installed to a depth of 13.7 m (45 feet). One inclinometer was installed near the top of the slope (uphill) and one inclinometer was installed up the slope from the RAPs area (downhill). The lateral displacement measured in the inclinometers was less than 5 mm (0.2 inches) as shown in Figure 5.

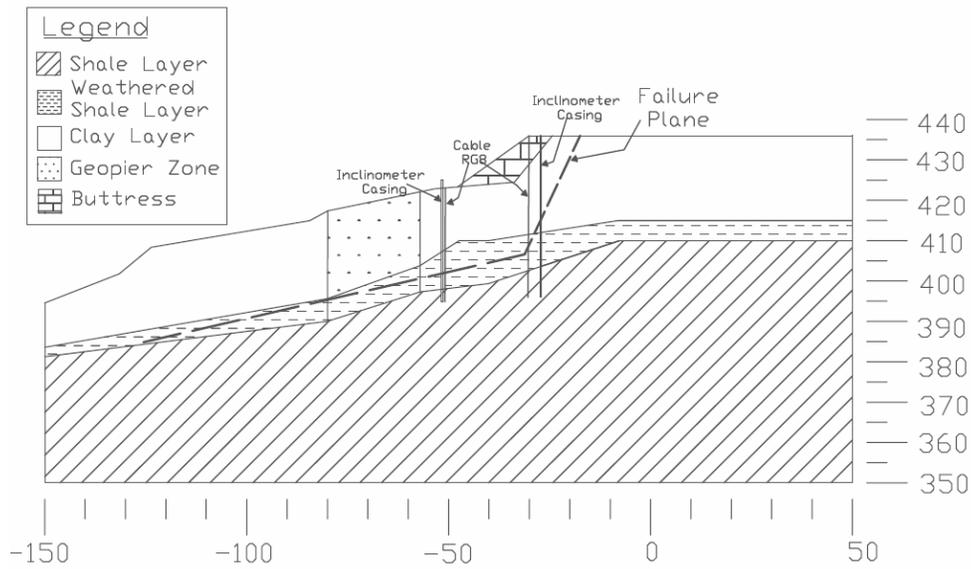
Figure 6- Pre-Stabilization Instrumentation Plan (units in Feet)

In March of 2003 the Arkansas State Highway and Transportation Department requested the Civil Engineering Department at the University of Arkansas to monitor movement in an approximately 91 m long (300 feet) active slide that was encroaching into the south bound lanes of Highway 167 just South of Batesville, endangering an adjacent motel facility. The soil profile in the slope consisted of sand fill and soft sandy clay over soft to hard shale. Remnants from previous repair attempts and numerous boulder-size rock fragments were encountered at random depths within the overburden soils. Perched groundwater was encountered at depths ranging from 1 to 4 meters (4 to 12 feet) within the stratum. The slide was monitored in two locations using both inclinometers and Total Deformation Reflectometer (TDR) cables as illustrated in Figure 6. The upper inclinometer casing was installed to a depth of 12.5 m (41 feet) on the right edge of the slope crest along the traveled way. The lower casing was installed to a depth of 10 m (33 feet) about mid-way down the slope. In addition to inclinometer casings, TDR cables were grouted into adjacent 0.1 m (0.3 feet) diameter boreholes drilled to the same depth as the inclinometer casings. Both inclinometers and the TDR cables were monitored on a monthly basis for a period of six months to determine the location of the failure surface.

The RAP mitigation solution for obtaining a minimum factor of safety of 1.3 resulted in an area replacement ratio of 38% within the middle third portion of the slope (identified as Geopier zone) as shown in Figure 6. This resulted in a pier spacing of 1.1 m on-center (3.5 feet on-center), and shaft lengths of 7 to 7.5 m (23 to 25 feet) to completely penetrate through the soft shale and embed the piers 0.6 m (2 feet) into the underlying firm shale. Drilling complications related to the buried boulders and groundwater infiltration into the drilled holes led to the construction of surficial bleeder ditches. The ditches were excavated to depths of about 2.4 m (8

feet) and were approximately 1.2 m (4 feet) wide. The cavities were backfilled with crushed limestone, 5 to 10 cm (2 to 4 inch) nominal particle diameter. After pier installation the slope face was regraded.

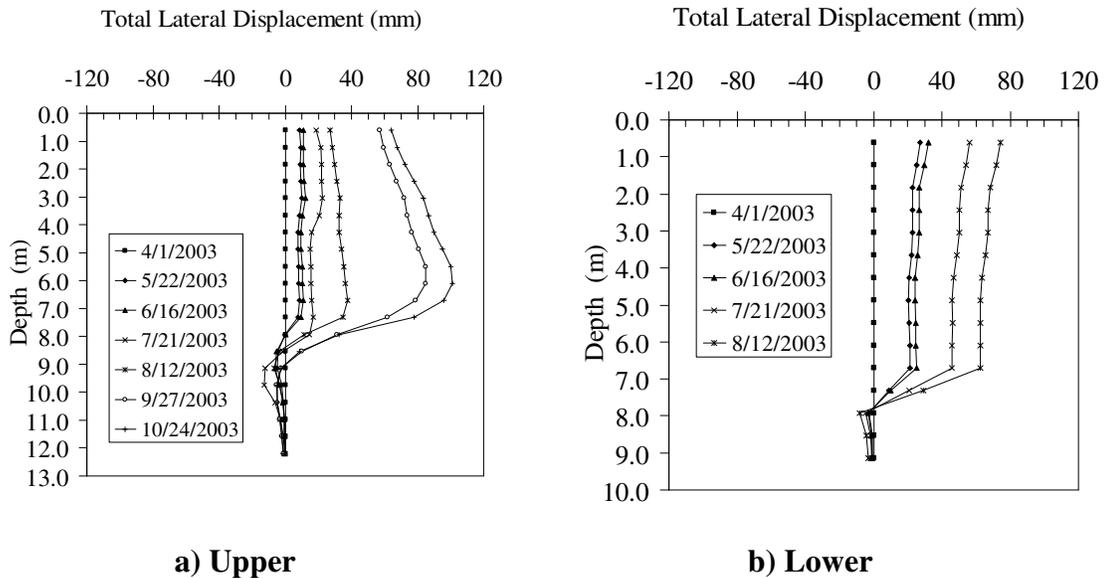
Figure 7- Summary of the Pre-repair Inclinometer Data at Highway 167 Near Batesville, AR.

During the monitoring period both the inclinometers and the TDR cables indicated movement. Figures 7 and 8 illustrate that movement. Incremental movement reported in Figures 7 and 8 illustrate that a distinct failure surface developed at approximately 7 m (23 feet) in the upper inclinometer casing. That failure surface was also detected by the TDR cable at a depth of 7.5 m (25 feet) as indicated by the downward “spike” of the waveforms in the circled region in Figure 8. Significant deformation was experienced in the failed mass, causing the lower inclinometer casing to be sheared four months into the monitoring program impeding further inclinometer readings. The TDR cable, however, continued to report movement until the end to the monitoring program. The shear surface was identified passing through the soft shale.

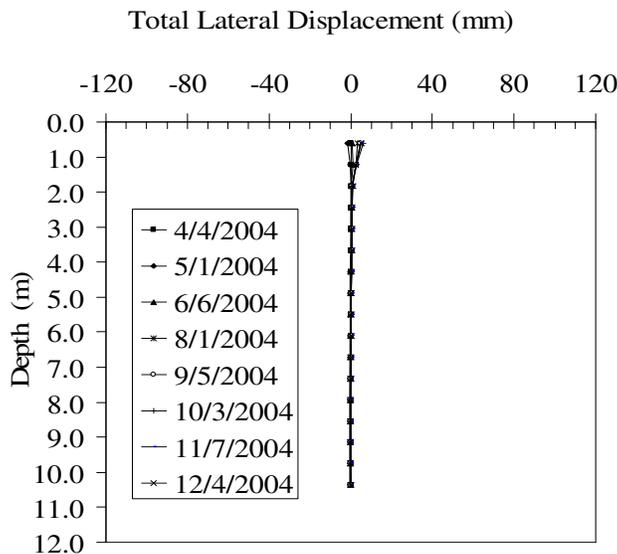
Figure 9- Post-Slope Repair Lateral Displacement Monitoring Results.

Following the slide repair, new inclinometer casings and TDR cables were installed in the vicinity of the pre repair monitoring locations. In addition to monitoring movement of the slope, the Arkansas Department of Transportation also wanted to monitor water levels in the slide area. For that purpose, the inclinometer casings were converted into pseudo-piezometers by perforating the area between the grooves with 6.5 mm (0.25 inch) holes for the lowest 3 m (10 feet) of each casing. The casings were again installed in 200 mm (8 inches) diameter boreholes. However, rather than grouting the full length of the casing like the pre-repair inclinometers, the lowest 5 m (16 feet) of each borehole was backfilled with pea gravel before grouting to the surface with a weak bentonite-cement grout. TDR cables were grouted in adjacent 100 mm (4 inches) diameter boreholes using a bentonite-cement grout having an unconfined compressive strength of 1,725 kPa (250 psi). During the one year monitoring period following the repair, no significant movement was observed at any of the monitoring stations. Figure 9 provides a summary of the movement reported by the lower inclinometer. Water levels in the inclinometer casings were observed at every visit during the post-repair monitoring program. The free water surface in the upper casing ranged from 5.5 to 6.5 m (18 to 21 feet) below the ground surface while levels in the lower casing ranged from 2.6 to 4 m (8.5 to 13 feet) below the ground surface. The trend of the free water surface in both casings was downward during the monitoring period. By comparing these water levels to the stratigraphy portrayed in Figure 6, one can see the free water surface was nearly horizontal across the failure site and was located approximately 1 to 2 meters (3 to 6.5 feet) above the weathered shale.
