Slope Rehabilitation at the Baltimore-Washington Parkway Using Rammed Aggregate Piers

**Transportation Research Board
83rd Annual Meeting
January, 2004
Washington, D.C.**

E. O'Malley¹, S. Saunders², and J. Ecker³

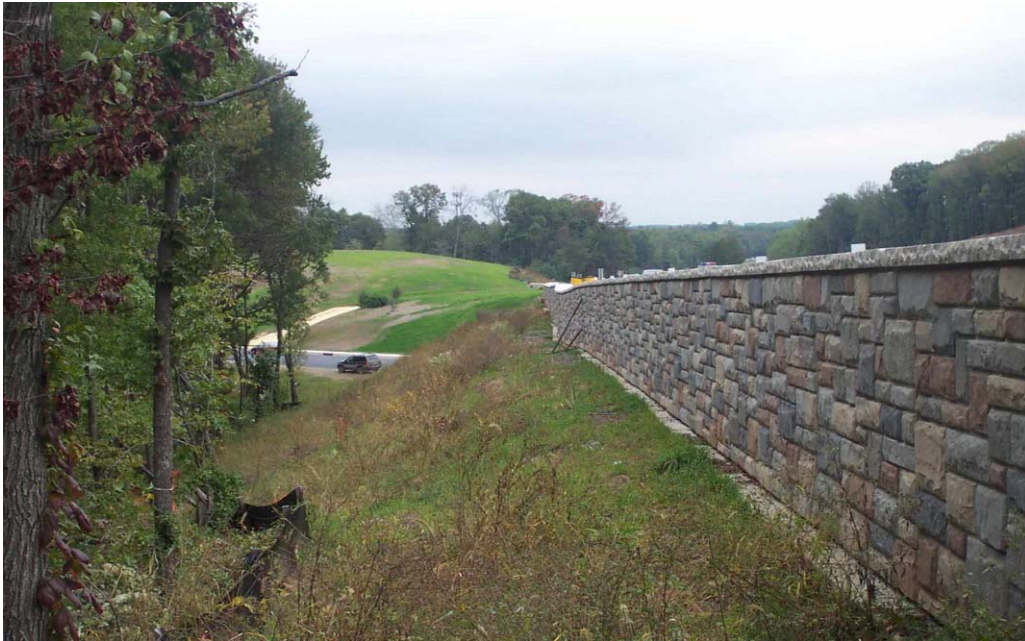
After a series of rainstorms in the fall of 2002, the north slope of the west abutment failed in the direction of the adjacent wooded area at the toe of the slope. The failure manifested itself as significant movement of the barrier wall and tension cracking in the pavement adjacent to the barrier wall (Figures 3 and 4). The slope failure extended approximately 100 m (330 feet) along the Parkway alignment. The surface of the slope was wet and had sloughed in a number of areas. Two underdrains were installed in the wettest areas. However, slope movements continued.

Based on the slope geometry, subsurface conditions, observed surface conditions, and inclinometer data, it appeared that the cause of the failure was softening of the plastic clay embankment soils. The loss of shear strength appeared to be linked to surface infiltration versus a rise in phreatic surface as a result of precipitation. Additionally, wetting and drying cycles of the embankment soils over time could have contributed to a loss of shear strength.

FIGURE 3. Photograph of failed slope area

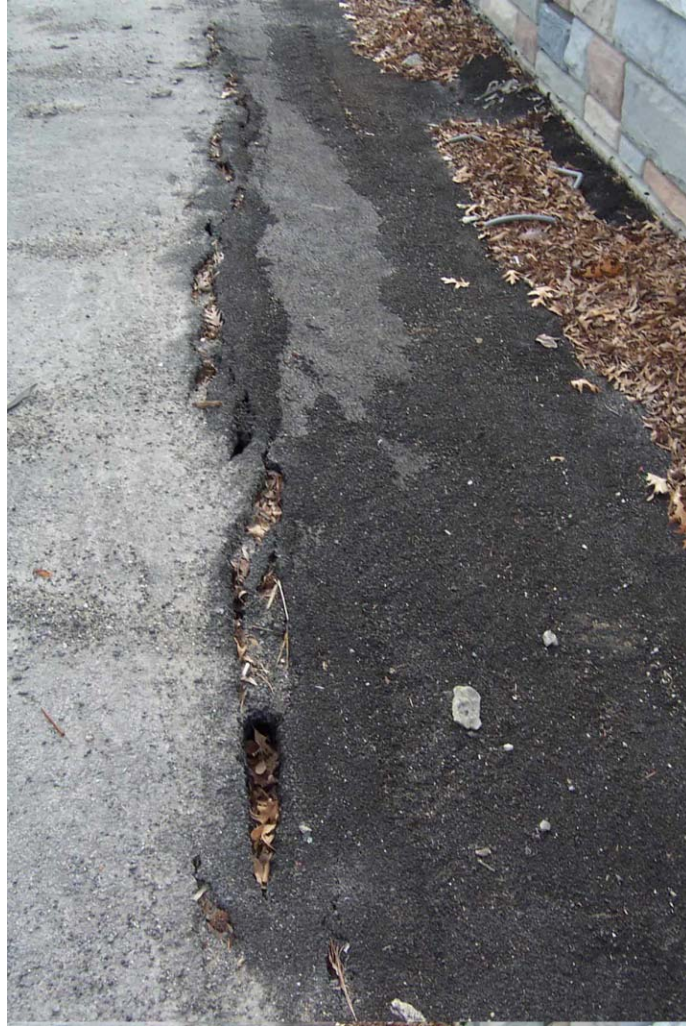
FIGURE 4. Photograph showing distress in the roadway behind concrete barrier wall

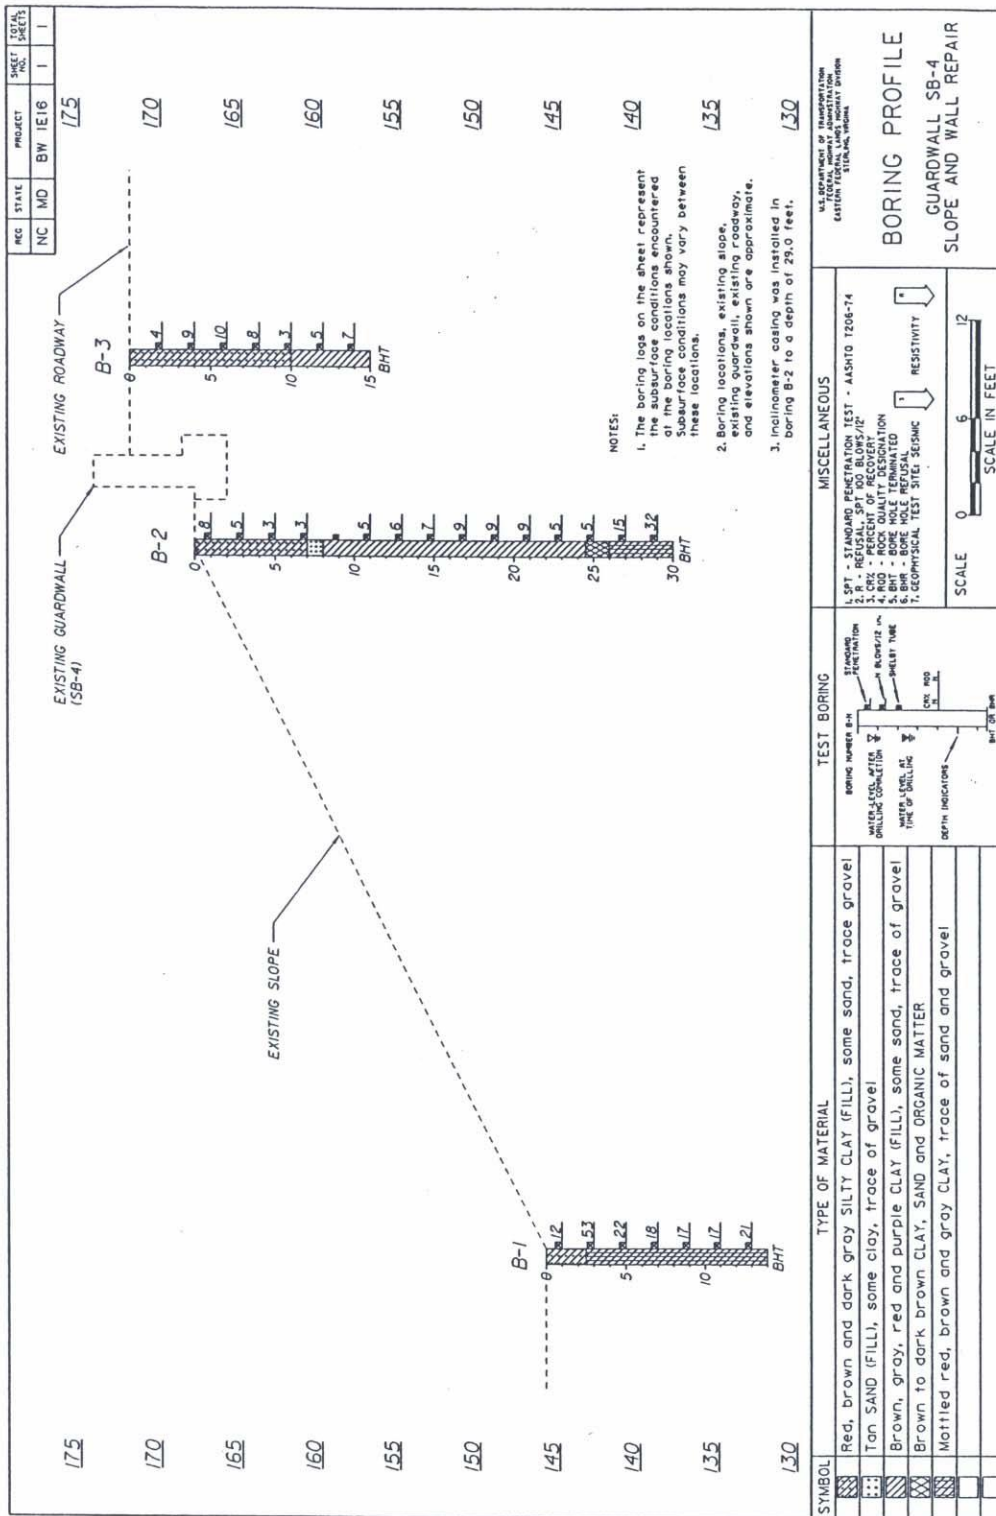
Figure 5 presents a cross-section showing the geotechnical conditions encountered in the borings. The fill embankment was constructed using predominantly clayey soils. Standard penetration and classification test results are summarized in Table 1. A direct shear test was performed on an undisturbed sample taken from boring B-2 at a depth of 2.5 to 3 m (8 to 10 feet) below the ground

surface. Test results are summarized in Table 2. The embankment foundation soils consisted of highly-plastic Coastal Plain soils with standard penetration test N-values ranging between 5 and 53 blows per foot (bpf).

FIGURE 5. Cross-section showing slope geometry and conditions in soil borings

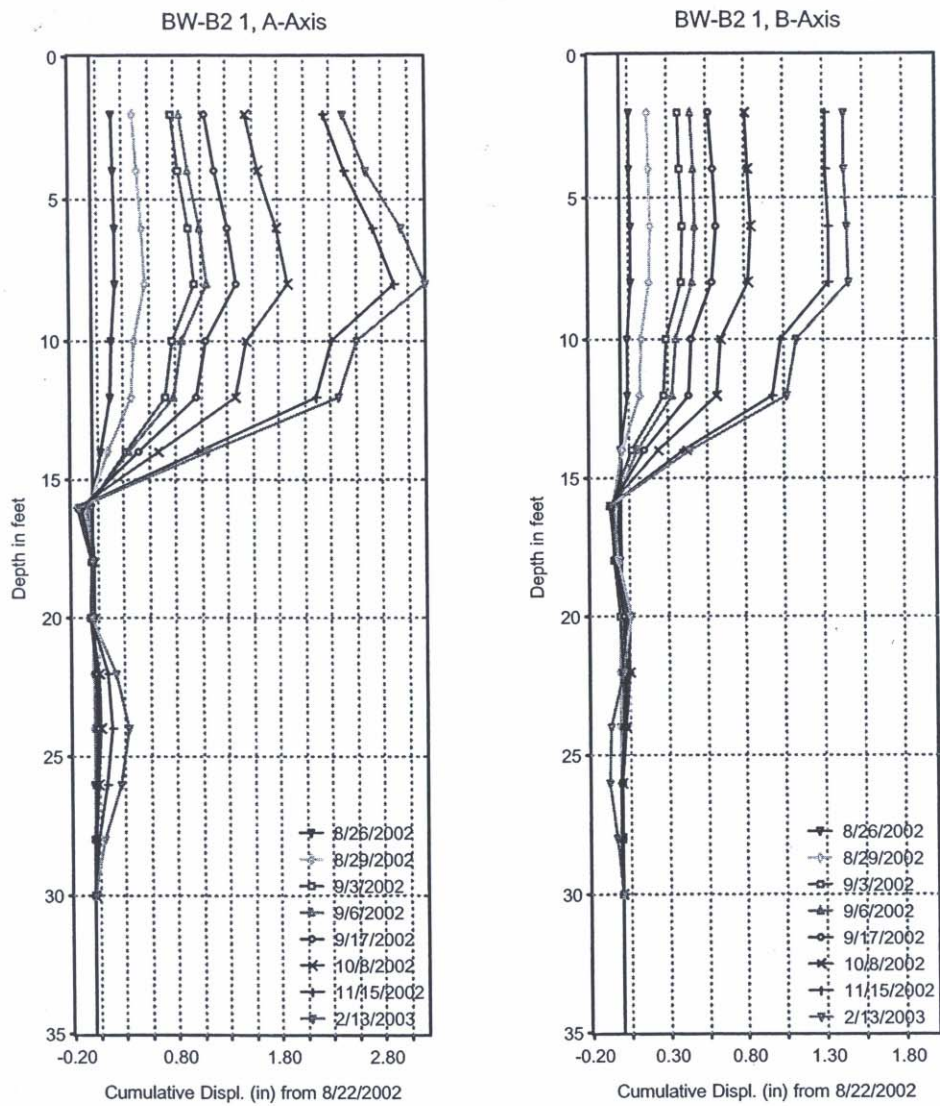
Slope inclinometer profiles measured after the slope failure are presented in Figure 6. The inclinometer installed within boring B-2 advanced near the slope crest indicated slope movements were experienced in the upper 5 m (16 feet) of the soil profile after the failure had already occurred.

Inclinometer located 3-ft down slope from wall footing along edge of Southbound BW Pkwy.

FIGURE 6. Slope inclinometer profiles measured after slope failure

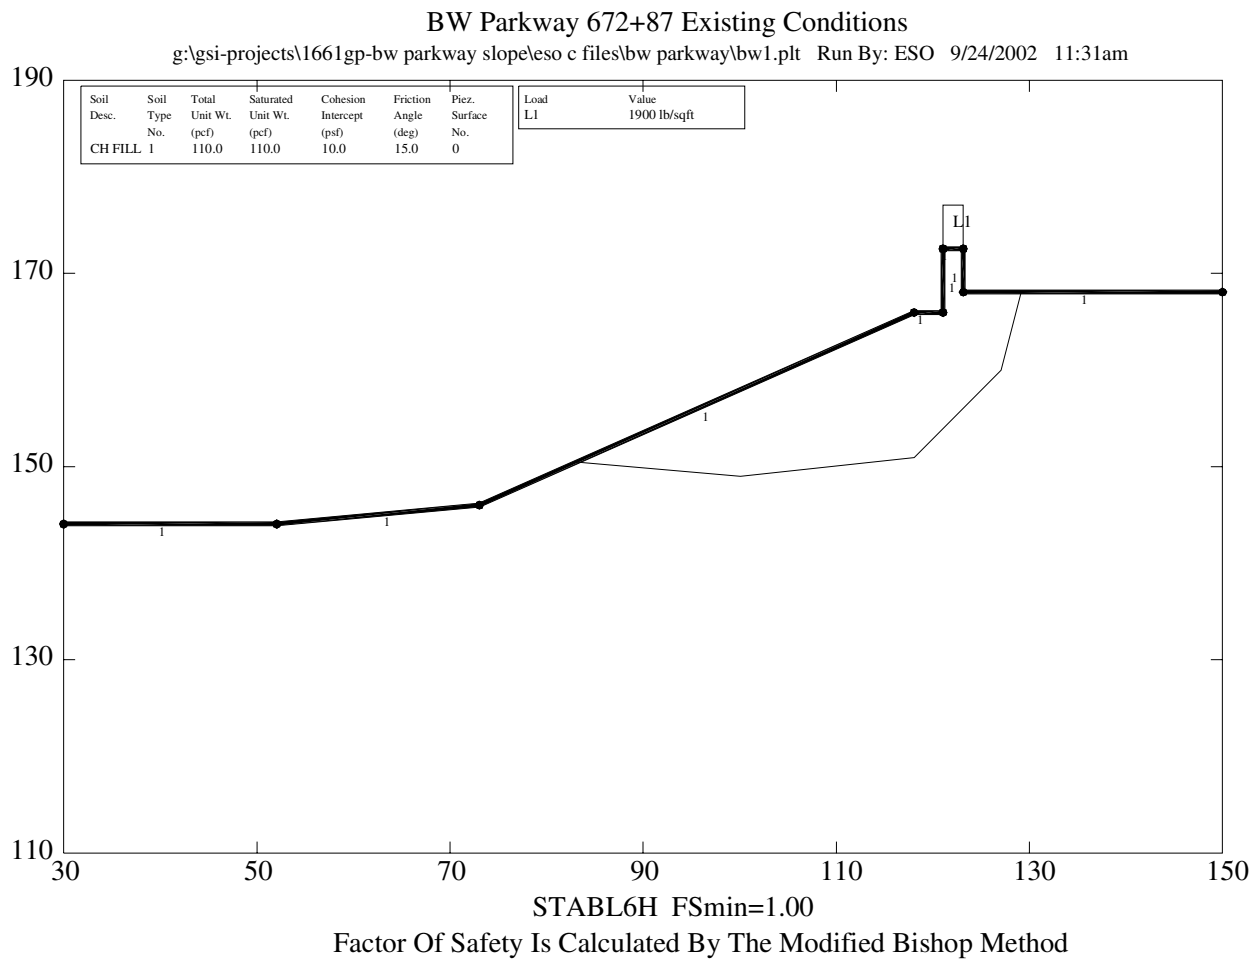
After the completion of the supplemental geotechnical investigation, stability calculations were performed on the existing slope geometry using the computer program PCSTABL6H. The modified Bishop method of analysis was utilized. An existing failure surface was determined using the observed cracking in the Parkway pavement adjacent to the barrier wall and the failure surface elevation determined in the inclinometer casing. Various probable angles of internal friction were analyzed using the existing slope geometry, the probable failure surface, and a factor of safety of 1.0. Figure 7 presents the results of the analyses for failed conditions using trial shear strength parameters. Shear strength parameters and appropriate soil properties to be used in slope stabilization design were determined based on backcalculations and laboratory test results with input from FHWA geotechnical engineers assigned to the Administration's Eastern Federal Lands Highway Division. A drained angle of internal friction of 18 degrees and a cohesion intercept of 1 kilopascal (20 pounds per square foot, psf) were used in design of the slope stability system.

FIGURE 7. Slope stability analysis results – failure conditions

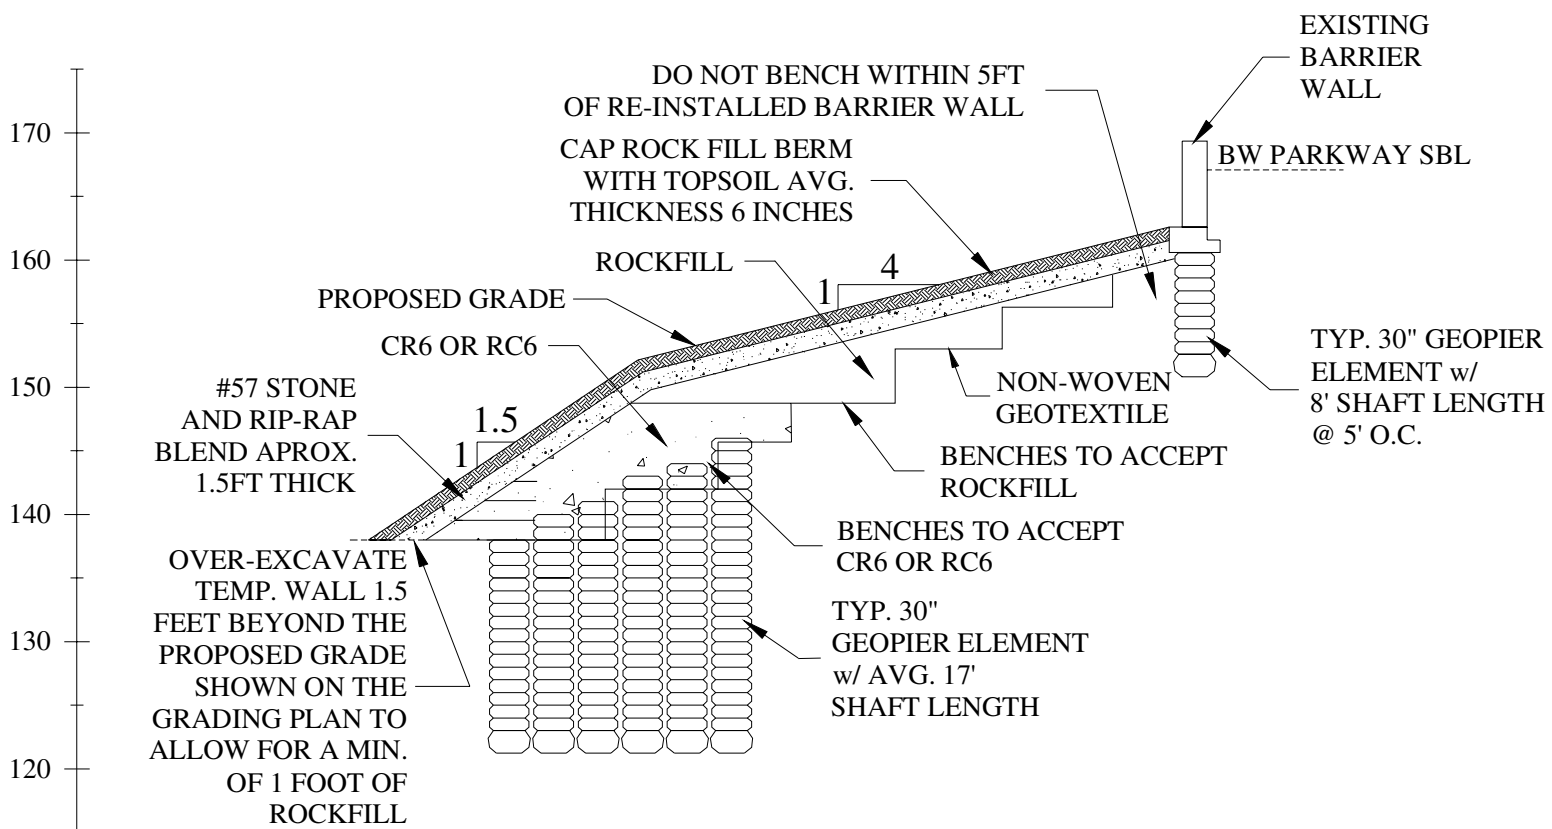
FIGURE 8. Cross-section of selected slope stability option

In order to achieve the minimum factor of safety of 1.25 for the final conditions along the slope, it was determined that a counterbalance berm would also be required. The berm breaks the slope angle into approximately a 4(H):1(V) angle in the upper half and a 2(H):1(V) angle in the lower half. The steeper lower half is armored with riprap-sized crushed stone. The berm also resulted in increased shear strength of the rammed aggregate piers due to the additional confinement and increased normal stresses on potential failure planes. The effects of the increased composite shear strength as a result of installing piers to support the barrier wall were also considered in the analyses.

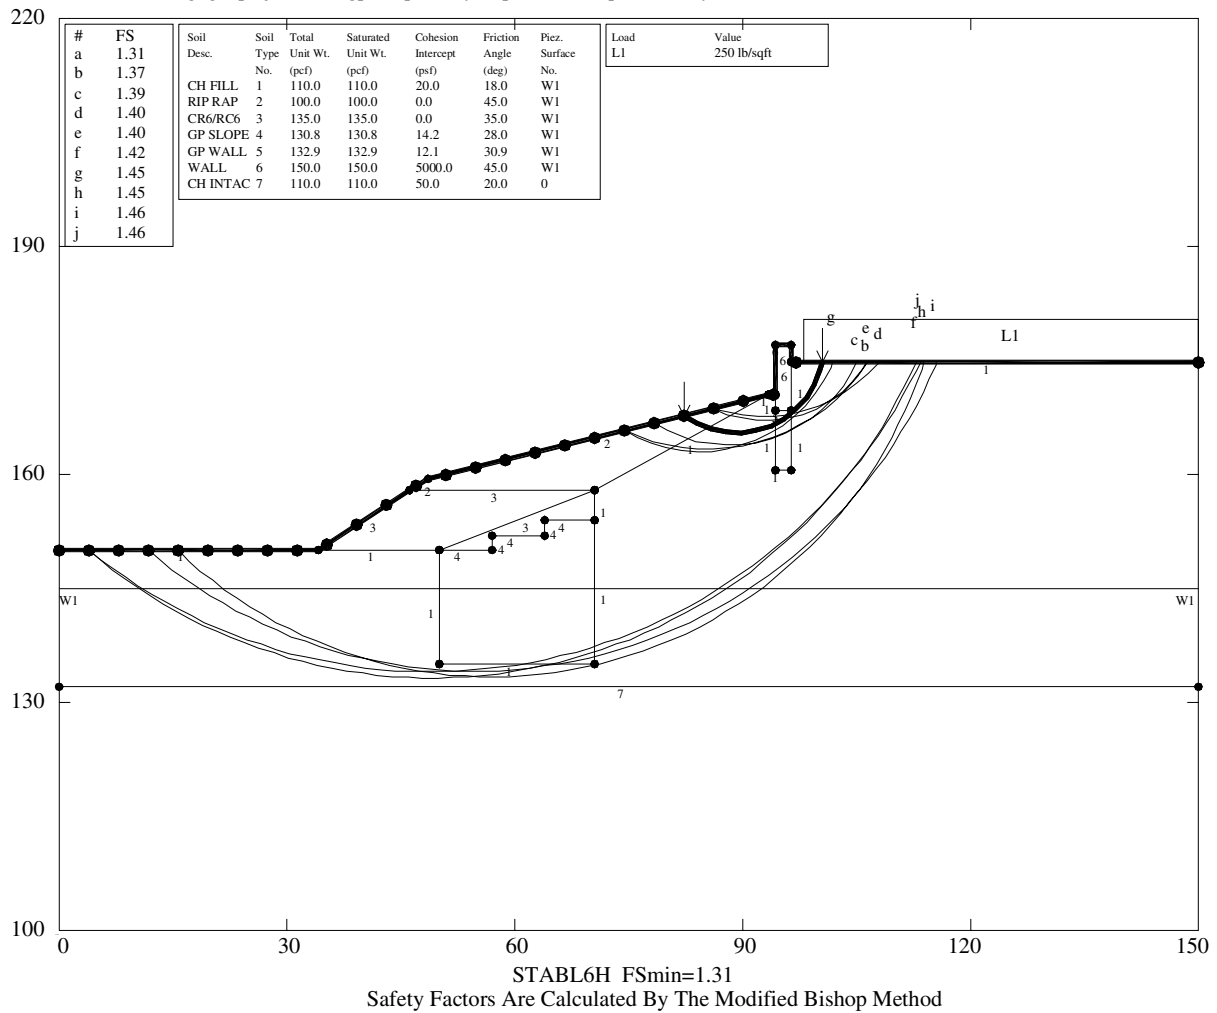
BW PARKWAY/MD 197 INTERCHANGE STA. 671+50 FINAL CONDITION (RC6)

Stability analyses were performed using PCSTABL6H and a circular surface search routine. Representative results of stability analyses performed for the design solutions are presented in Figure 11.

FIGURE 11. Slope stability analysis results – design conditions

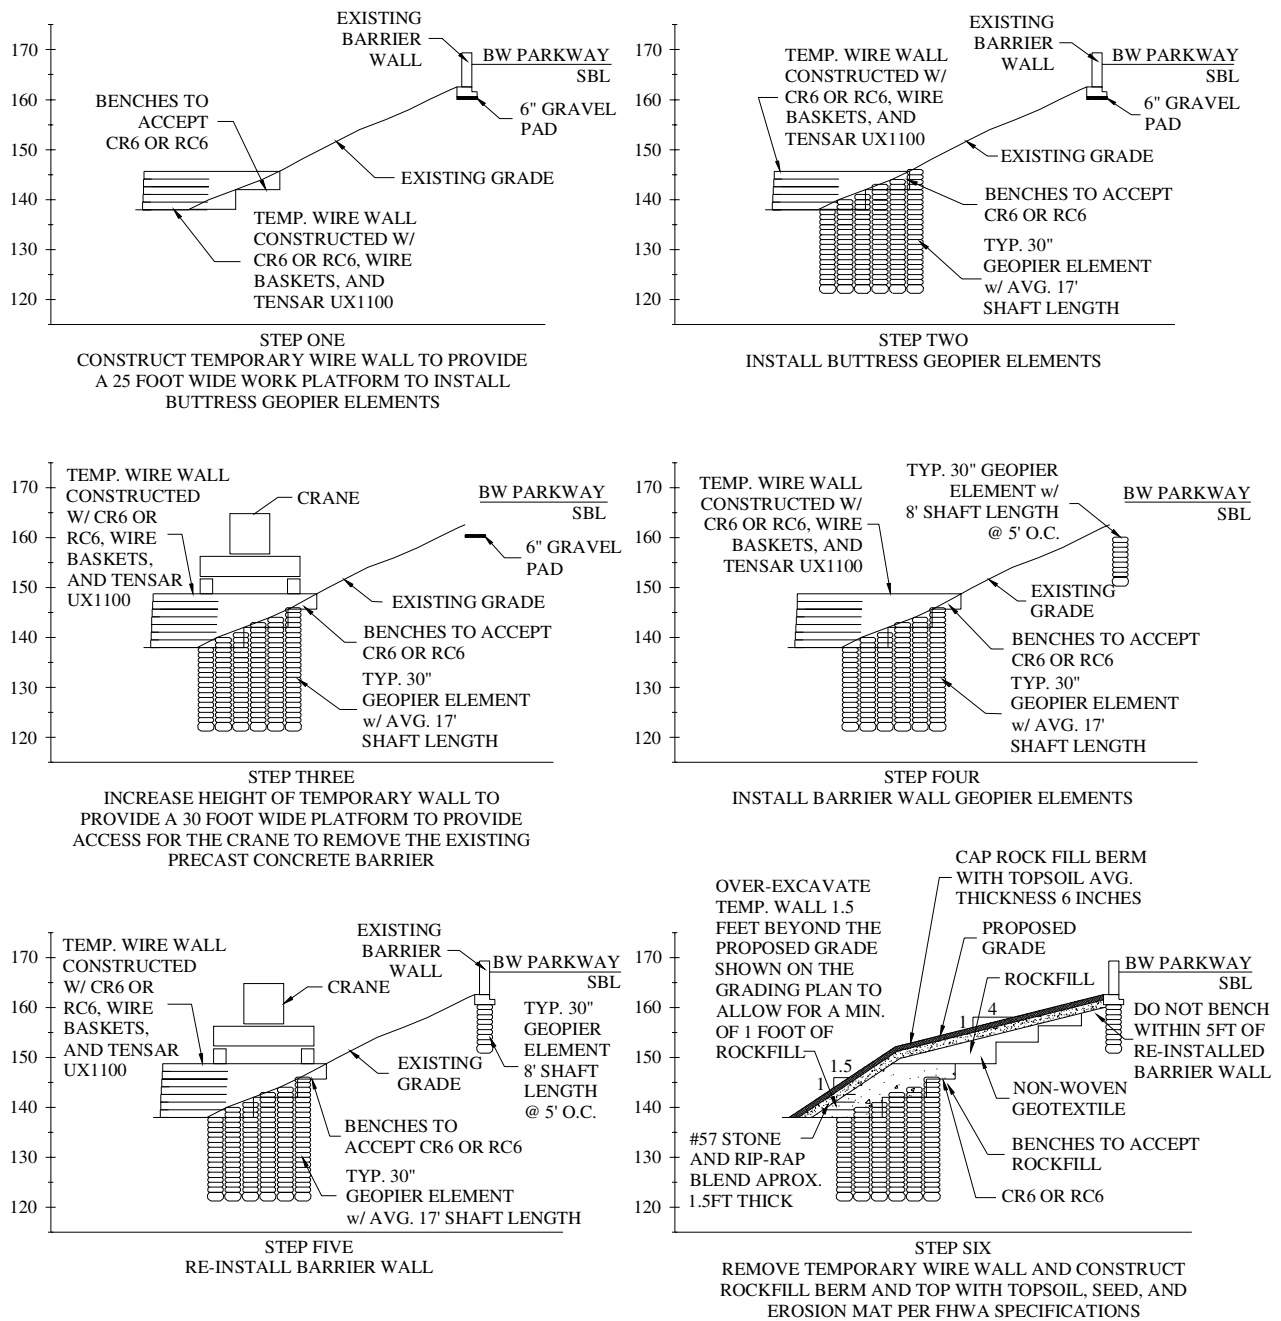
FIGURE 13. Six-step stabilization construction sequence

The toe berm was constructed utilizing a wire basket and geotextile wrap facing system and Tensar UX1100 uniaxial geogrid. The six-step process involving berm construction, toe pier placement, crane activity, wall pier placement, and final grading is shown in Figure 13.
