## Plate Piles™ Stop Active Landslide

Salina, Utah

### Geopier SRT® system selected for emergency slide repair at Fishlake National Forest

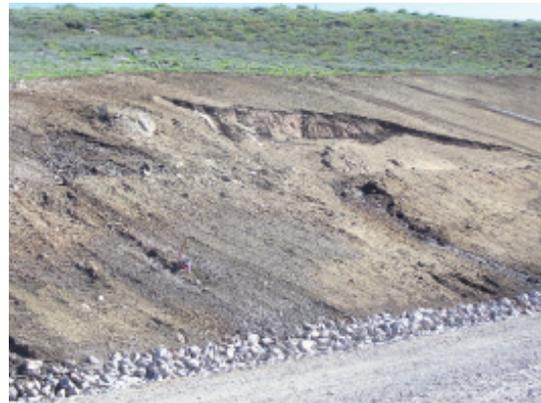
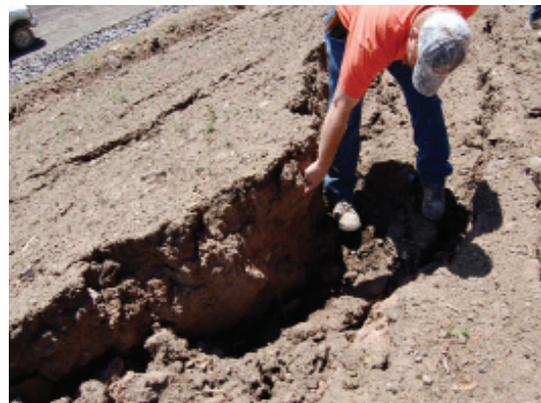
**Geopier Solution:** Using the Geopier SRT® system, the slides were repaired with minimal earthwork consisting only of re-grading the slope to conform to the original pre-slide contours. Immediately after the slope regrading, the repair commenced using two excavators fitted with hydraulic hammers. One excavator was positioned at the top of the slide area and the other at the bottom. At the time that the repair of the larger 7-foot-deep slide began, the slide mass was still moving about 2 centimeters per day. Workmen laid out the Plate Piles™ location and drove to design depth in spite of ongoing rain and sleet.

The two landslides were repaired in one day. A total of 107 Plate Piles were installed to repair both landslides.
