**Testing and Evaluation of Driven Plate Piles in a Full Size Test Slope:
A New Method for Stabilizing Shallow Landslides**

Richard Short, P.E., G.E.
Kleinfelder, Inc.
General Manager and Chief Geotechnical Engineer, Blackhawk Geologic Hazard Abatement
District
4125 Blackhawk Plaza Circle, Suite 103, Danville, California, 94506
(V) 925-964-0823, (F) 925-964-0825, (E) dshort@kleinfelder.com

Submission Date: August 31, 2005

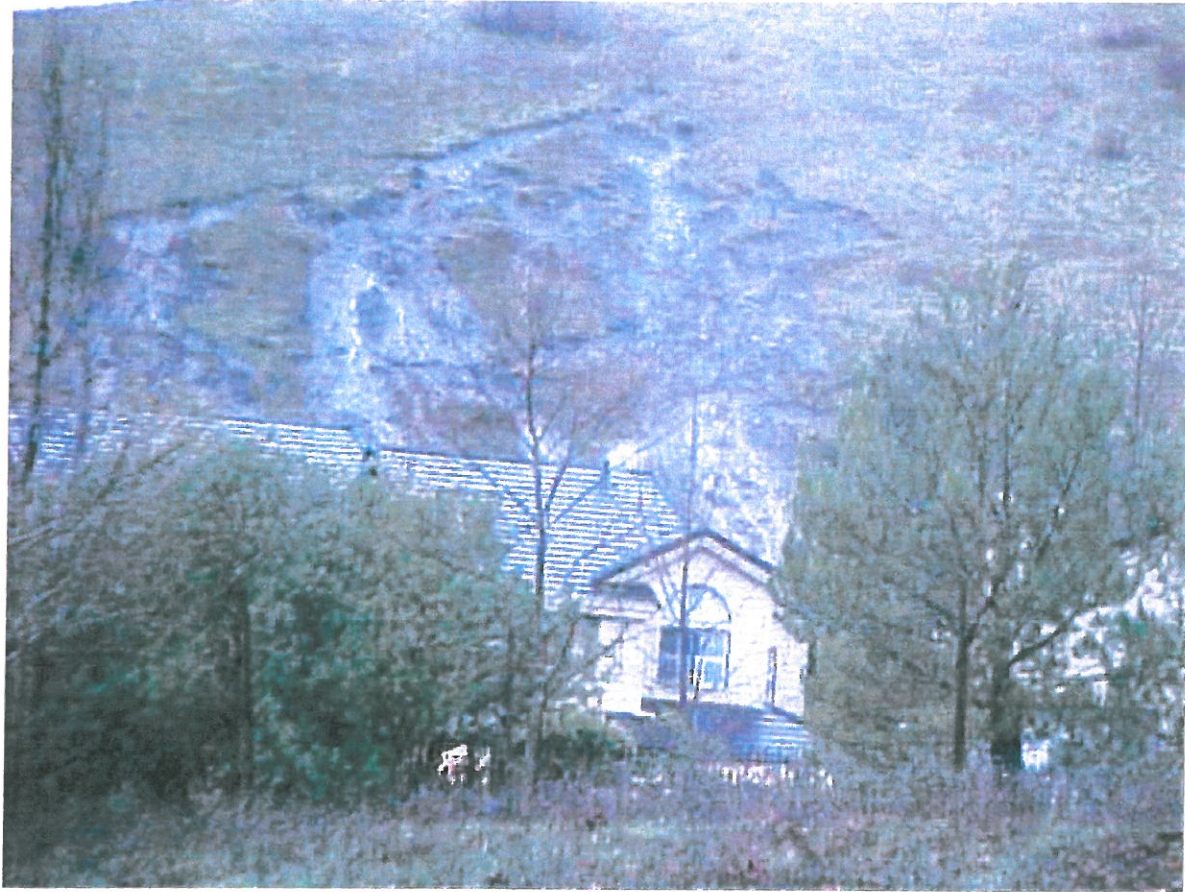
FIGURE 1 One of 60 shallow landslides occurring on December 15, 2002 in Blackhawk, California.

In the residential community of Blackhawk, California, located east of the San Francisco Bay, these types of landslides are a common occurrence (Figure 1). However, shallow landslides have also been a repetitive and constant problem along many state highways where steep embankments have been constructed in close proximity to busy thoroughfares. Given the real threat to property values in residential and commercial settings and the constant maintenance problem posed to lifeline structures such as utilities, roadways, and pipelines, new methods to deal with these landslides are needed.

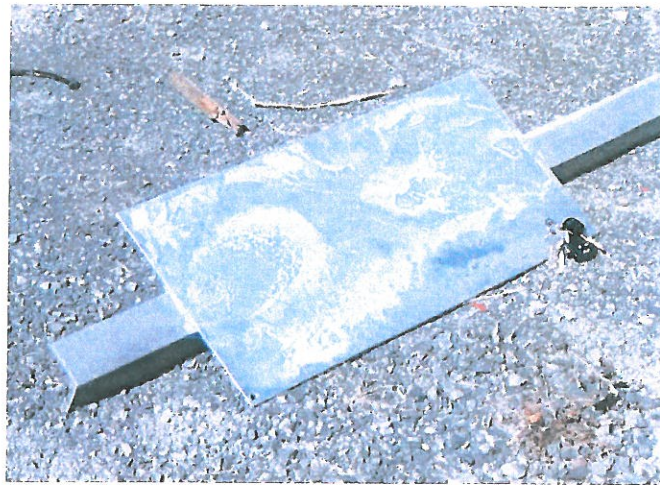
FIGURE 3 Details of typical galvanized steel plate pile.

The plate pile mitigation technique (patent pending) is based on increasing a slopes' resistance to sliding through shear stress absorbing bending elements inserted vertically into the slope. In a typical application, the bending elements are 6-foot long, 2 ½ inch angle, galvanized steel sections with a 2-foot by 1-foot, rectangular steel plate welded to one end (Figure 3). The plate piles are driven into a potential slide area typically consisting of 2 to 3 feet of residual or colluvial soil over a stiffer bedrock or fill interface. Being driven piles, the bedrock must be sufficiently weak to allow the insertion of the plate pile without undue stress on the pile tip. To date, plate piles have successfully been installed in claystone and weak sandstone units. The plate acts to reduce the driving forces of the upper slope mass and transfer this load to the stiffer subsurface strata. Plate piles are installed on an offset grid with 4-foot cross slope spacing and 10-foot down slope spacing taking full advantage of the arching effect between adjacent piles.

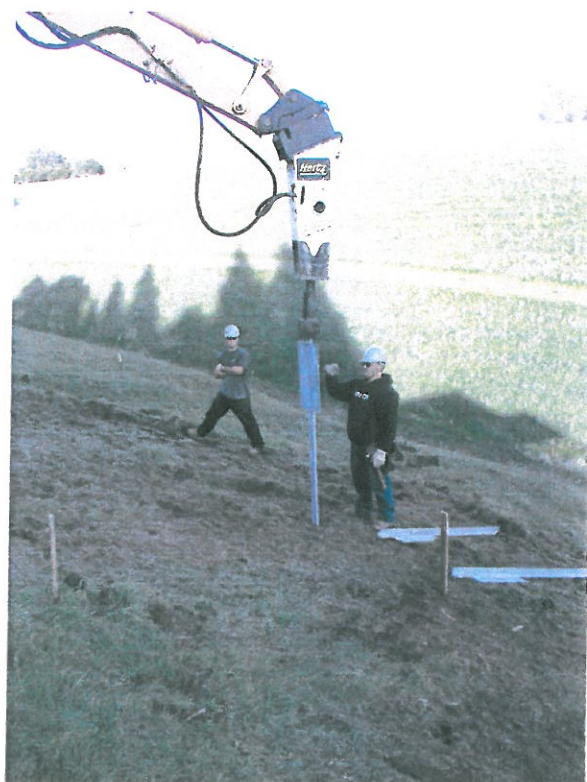
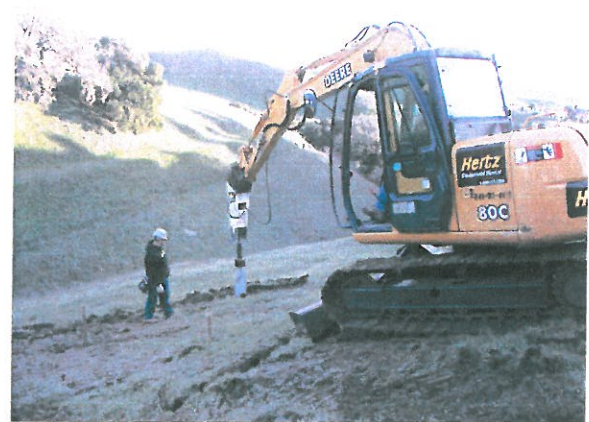
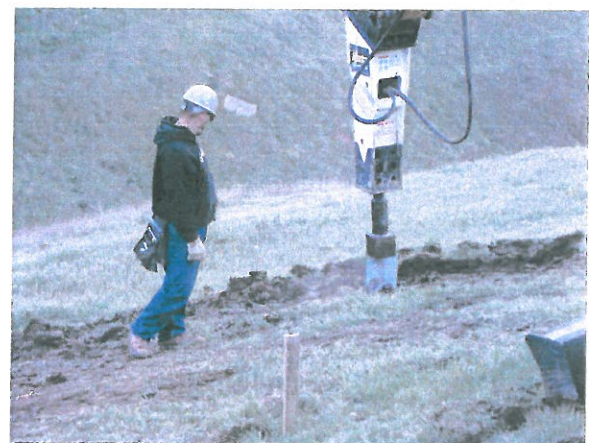
FIGURE 4 Typical installation of plate piles: (a) alignment of plate pile, (b) driving plate pile into upper colluvium, (c) hoe ram driving into claystone bedrock.

Thus far, plate piles have been installed in two projects with over 7000 piles in the ground with no problems to date [13]. Individual plate piles are sufficiently light so that they may be maneuvered into position by a single worker. An excavator, outfitted with a 500 lb hoe-ram with a driving head adaptor is then used to drive the plate pile through the weaker surficial soils and into the stronger underlying strata (Figure 4). In situations consisting exclusively of fill, plate piles may be pushed directly into the subsurface layers without the aid of the hoe-ram.

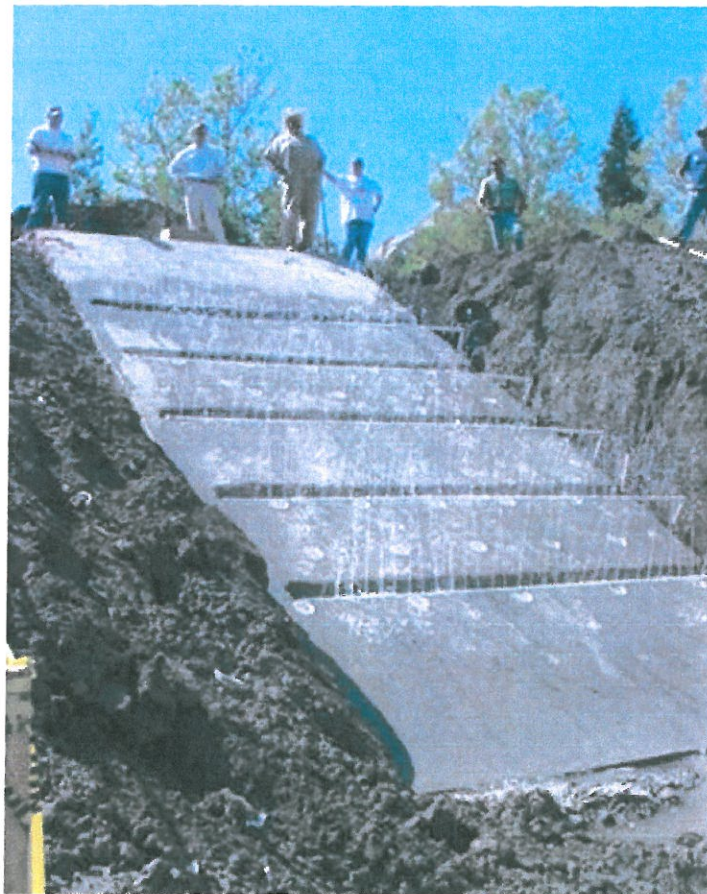
FIGURE 5 The Blackhawk GHAD Test Site with bottom irrigation tubes turned on.

To test the effectiveness of the plate pile stability method, a series of full-scale field tests were performed at the Blackhawk Geologic Hazard Abatement District (GHAD) Test Site. The test site consists of a 12-foot wide by 30-foot long concrete slope upon which shallow translational landslides can be initiated (Figure 5). Soil is backfilled and compacted on the concrete slab to test specifications and sliding is initiated or attempted through a combined effort of surface irrigation and subsurface infiltration effects. Tests thus far have consisted of a 3-foot thick fill compacted directly on the concrete slab.

The slope is inclined at 26.6° (2H:1V) and outfitted with both surficial and subsurface irrigation systems so that precipitation and groundwater seepage effects can be simulated. The concrete surface mimics a shear plane and a ponding surface so that shallow surficial failures occur on the concrete slope. The 2-foot thick concrete slab is outfitted with a geometric arrangement of PVC tubes in which various configurations of plate piles can be inserted. The concrete slab provides the necessary resistance to the plate piles to transfer shear loads to the deeper subsurface. For control tests in which no plate piles are inserted into the slope and landsliding is initiated, the tubes are capped to prevent infiltration through the slab and to provide a smooth surface for sliding.

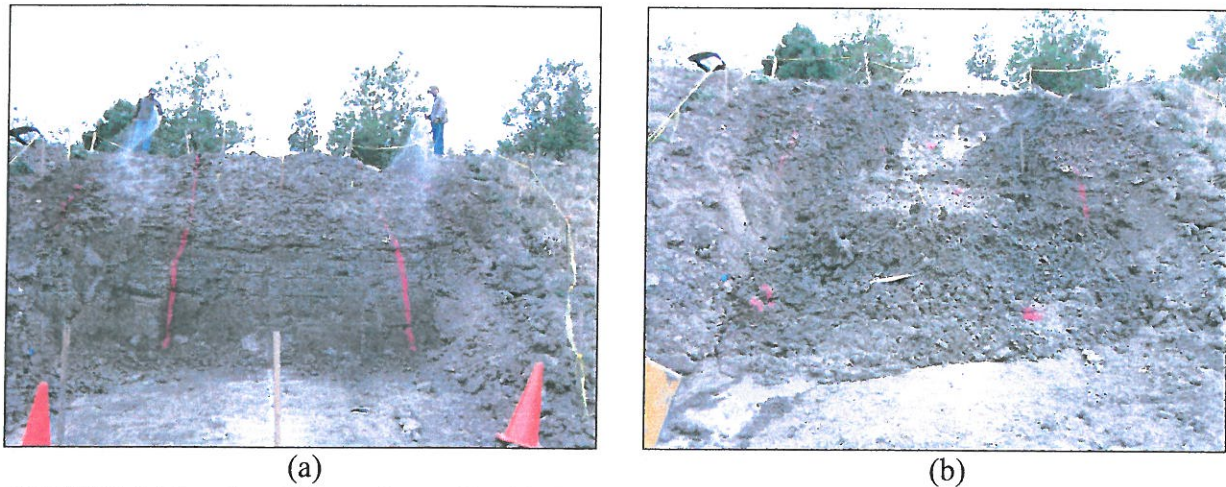
FIGURE 7 Test 1 -without plate piles (a) during irrigation and (b) following failure.

Failure of Test 1 occurred as a translative failure, initiating over the entire slope length. Within 3 minutes of prolonged bottom irrigation (5 minutes of total bottom irrigation), tension cracks along the entire slope crest opened as much as 1-inch. Two minutes later, complete failure began, with the entire slope first sliding as a solid mass on the concrete interface, then mobilizing into a thick slurry/debris flow mass. The run-out of the slide mass reached 13 feet beyond the slope toe (Figure 7b). The water content of the side wall of the fill averaged 29.9% with the mobilized debris reaching 38.2%. The test slide morphology represented a typical slide for a residual/colluvial hillslope in the Blackhawk area.

crest of the slope, nor were any signs of translative movement observed in the supported slope mass. In only one location beneath the bottom row of plate piles did the slope mass move slightly downwards, away from the bottom of the plate piles. This was partially expected since the bottom portion of the slope mass is unsupported. Before and after photos of the Test 1 slope (Figure 7) can be compared with the Test 2 slope photos (Figure 8) for reference.

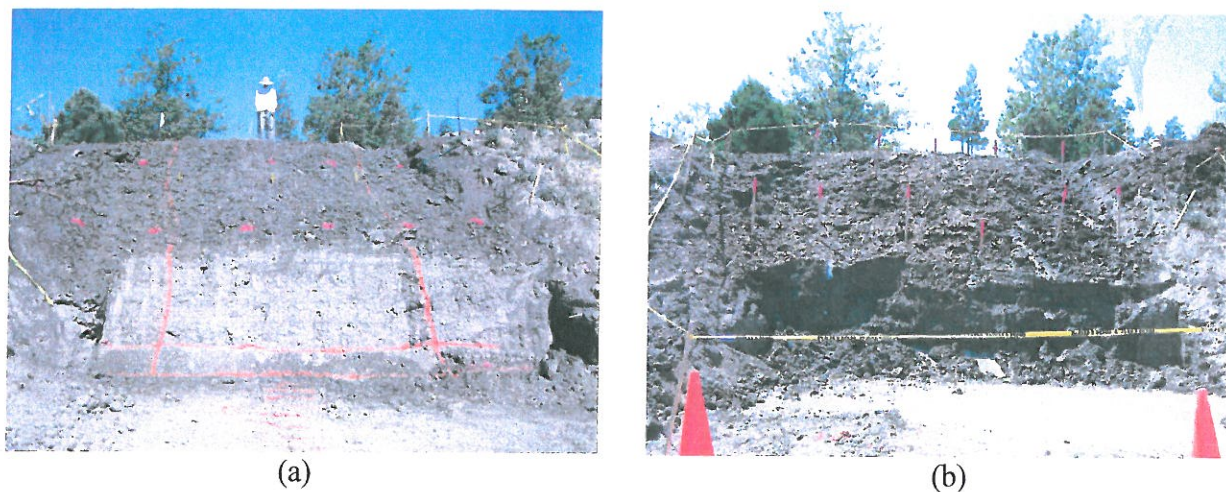
FIGURE 8 Test 2 - with plate piles (a) during irrigation and (b) at end of test without failure.

Test 2 did not reach failure and given the nearly identical testing conditions, the role of the plate piles in resisting sliding is self-evident. Here, no tension cracks were observed at the

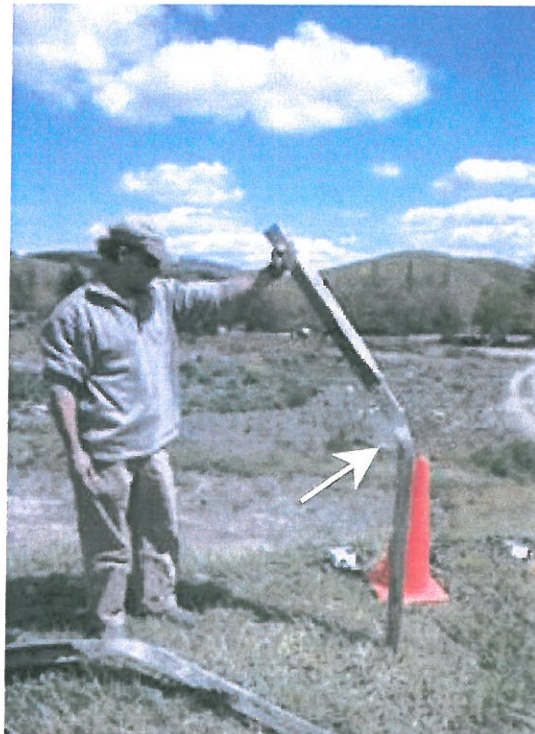
FIGURE 9 Ultimate strength testing of plate piles with formation of hinge point at yield.

An infinite slope analysis can also be performed taking into consideration the strength of the plate piles. From previous testing, it is known that plate piles fail in bending at a hinge point located at the midpoint of the steel angle section when subjected to direct loading of the plate. (Figure 9). A yield capacity analysis on the $2\frac{1}{2}'' \times 2\frac{1}{2}'' \times \frac{3}{8}''$ steel section shows that an equivalent load of 1100 lbs will cause failure of the section when loaded under these conditions. If a nominal amount of bedrock degradation is assumed from the pile driving process, the depth of fixity increases, reducing the equivalent failure load by approximately 10% to 1000 lbs. For a section of slope with this additional resistance, the factor of safety increases by 20%. However,

the additional 1000 lbs. of resistance should be viewed as a minimum value since soil backfill resistance behind the plate pile will provide additional strength. Based on full scale field tests, this value is in the range of at least 2000 lbs, which increases the factor of safety by nearly 40%.
