Boca de Briceño Approach Embankment

Briceño, Ecuador

The Impact® system effectively mitigated liquefaction on the foundation soils of an approach embankment, increasing its global stability during the April 16, 2016 Earthquake in Muisne, Ecuador, thus allowing the uninterrupted operation of the highway ensuing the earthquake.

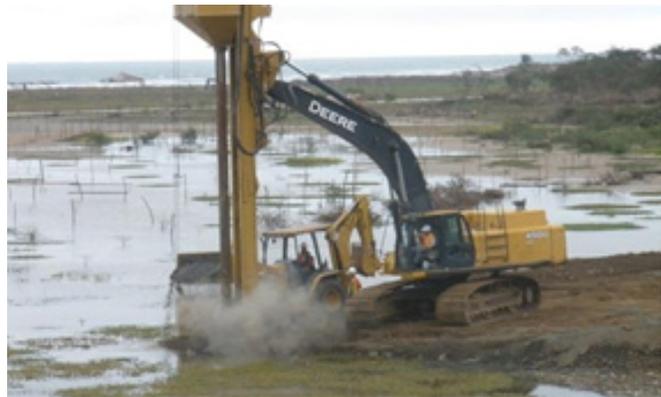
Figure 1: Installation of the Impact® system on Boca de Briceño

Geopier Solution: The foundation soils of the approach embankment were reinforced with Rammed Aggregate Impact® Piers from Geopier. The Impact® piers were installed under the entire footprint of the approach embankment at varying spacing, depending on their location, at different depths according to the depth of the liquefiable layers. The company Pivaltec installed more than 6,000 Impact® pier elements with only one field crew. The pier elements were installed using a patented displacement system that avoids spoils and does not require groundwater abatement nor the use of casing, thus yielding high construction rates that allowed delivery in a timely manner.

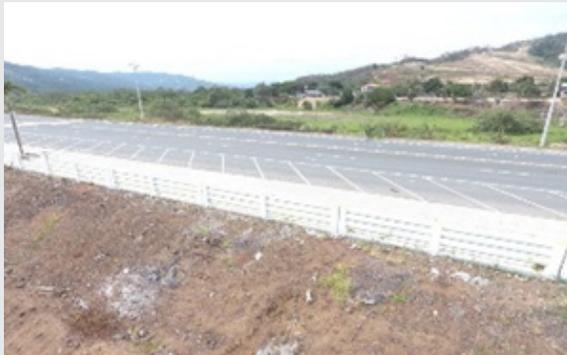
The Briceño embankment supported by Geopier Impact® piers.

Results: After the earthquake, the integrity of the embankment supported with the Impact® system was not jeopardized whatsoever, displaying only negligible settlements and surficial cracks in the asphalt roadway that were not substantial enough to disrupt the traffic flow at any moment.

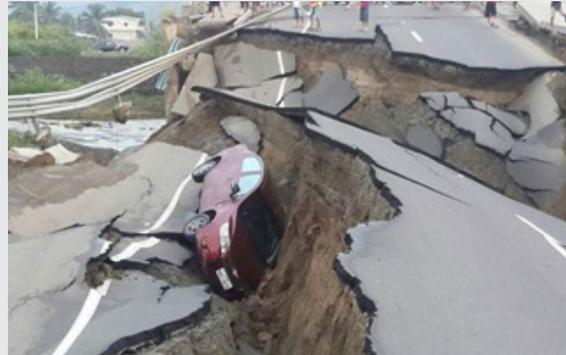
The Mejía embankment that was not supported with Geopier ground improvement.

Muisne, at about 112km from Briceño. Strong ground motions between 0.37 to 0.52g were recorded by the nearest strong motion stations. The natural disaster induced significant losses quantified in more than \$3,300 millions of dollars reflected in damage of infrastructure projects and at least 662 civilian casualties. Several embankments with similar foundation soil conditions, with no Impact® reinforcement, suffered damage due to liquefaction and eventual failure caused by global instability.
