Building on soft ground: a case study in Tauranga, New Zealand

D. Sandilands & B. O'Loughlin
Aurecon New Zealand Limited

ABSTRACT: Tauranga Crossing is a \$NZ200m+ retail shopping centre under development in Tauranga, New Zealand. The site comprises highly variable ground conditions, including a 10 to 15m deep cut into a ridge exposing sensitive, fluvially reworked rhyolite volcanic soils; and a low lying area underlain by soft peat and estuarine paleochannel infilled deposits which was raised by 3 to 5m with engineered fill placed in 2006. Since 2006, settlements beneath the filled area of up to approximately 1m have occurred and creep settlements are ongoing.

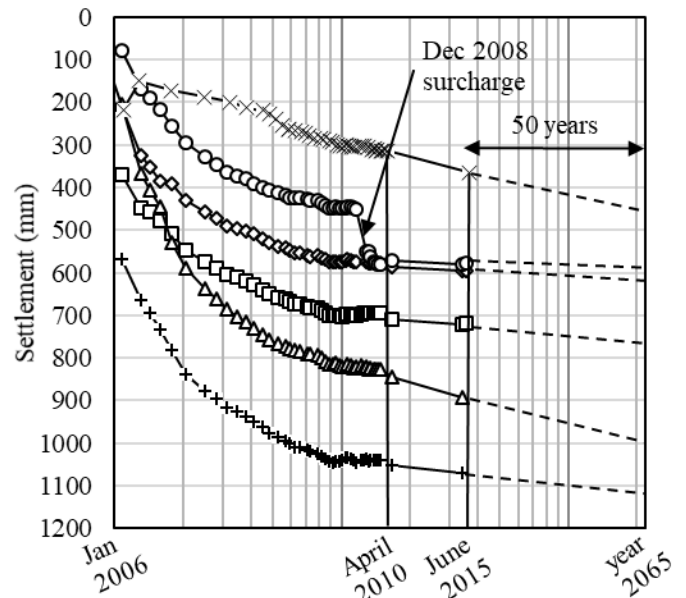
Figure 4: settlement monitoring data of the fill placed over the low lying area of the site (now the lower platform).

Settlement plates were used to monitor settlements induced by placement of fill over the peat and estuarine deposits in the low lying area. Since 2006, settlements of up to approximately 1m were recorded and further creep settlements of up to 100 to 200mm were inferred to occur by 2065 based on a 50 year design life, if left unmitigated (Figure 4).

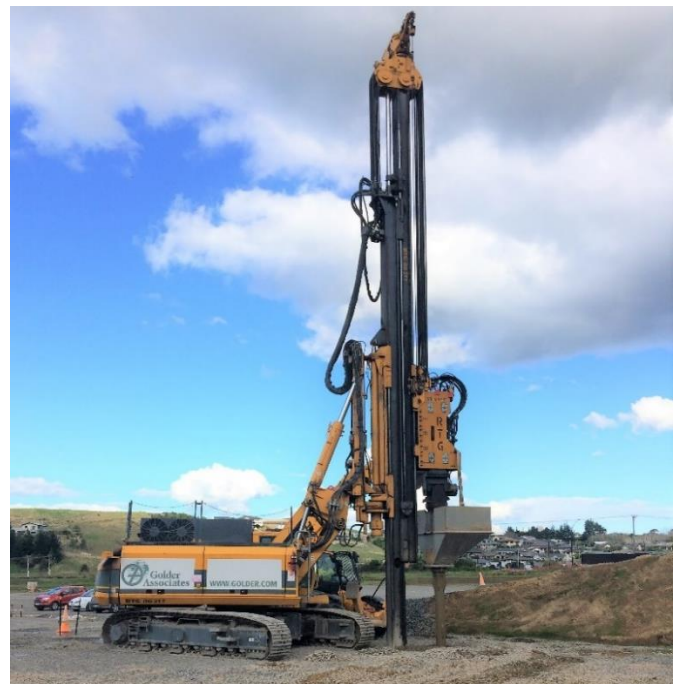
Figure 5: RAP installation rig at Tauranga Crossing.

Several ground improvement options were assessed at the preliminary design stage; deep soil mixed columns, driven timber poles, Rammed Aggregate Piers[®] and stone columns. RAP's are a patented technology of Geopier Foundation Company and are similar to stone columns, with the key difference being that the RAP's are built using downward pressure on the mandril that stone flows down, rather than a vibrating probe (Figures 5 and 6).

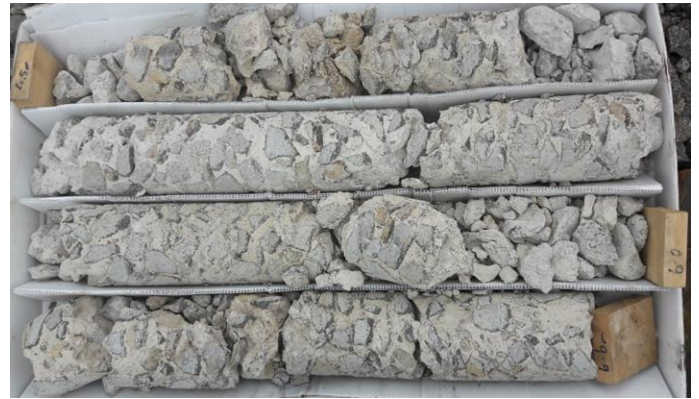
Figure 7: Grouted RAP core samples.

check its integrity and stiffness (Figure 7). Unconfined compressive strength (UCS) testing of three grouted RAP cores with strain measurement indicated a Young's modulus of 5 GPa for the grouted RAP's. RAP installation records included installation dates and duration, aggregate volumes, design depth and spoil volumes.

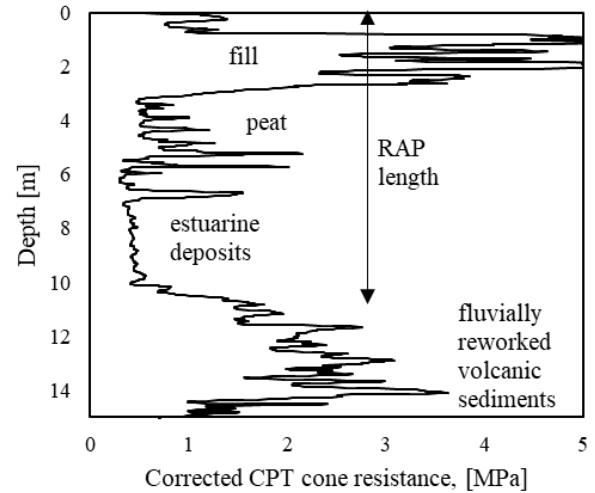
Figure 8: CPT trace at the footing load test

A full-scale load test was specified by Aurecon to validate the RAP design philosophy in respect of settlement mitigation and to confirm the load-settlement behaviour. The test was conducted at an actual footing location with plan dimensions of 3.5 m x 3.5m supported by five grouted RAP's, each 10 m long (note the upper 2m of each RAP was designed to be non-grouted). The ground conditions at the test location had not been subject to previous surcharging, and included 3m of fill, 3m of peat, and 4m of estuarine deposits. A CPT trace at the test location is shown in Figure 8.

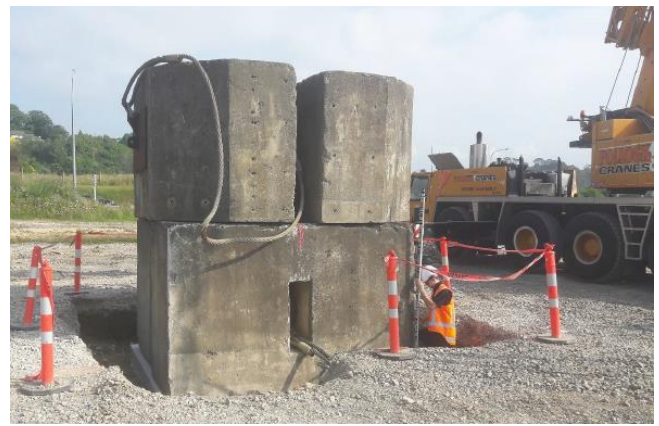
Figure 9: Footing load test

The load test footing was excavated to the true design depth and dimensions, followed by an inspection of the subgrade by an Aurecon engineer. A 200mm thick, 3.5 m x 3.5 m reinforced concrete slab was constructed at the approximate design subgrade level. Four concrete blocks (crane weights) weighing approximately 25 tonne each were placed on the slab, providing a test load of 1000kN (82kPa) (Figure 9). The serviceability design load on the tested footing was 900kN (74kPa), so the test load exceeded the design load by roughly 10%.
