Reinforcement of a Pipeline Right-of-Way in Eastern Kentucky: A Case Study

Yao Zhang, Ph.D., P.E., M.ASCE¹; Benjamin Taylor, P.E., M.ASCE²;
and Yazen Khasawneh, Ph.D., P.E., M.ASCE³

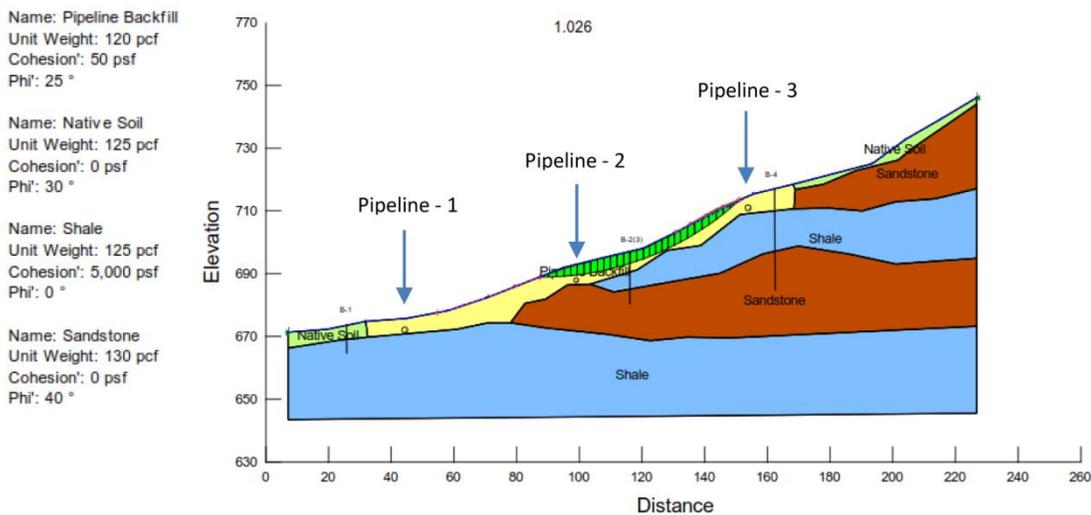
Figure 6. Inclinometer Locations and Its Surrounding Slope Conditions

Slope stability analysis was performed using the representative cross-section generated from the ERI test Line 2 (Figure 6). The purpose of the slope stability analysis was to model the observed tension-cracking and slope inclinometer monitoring results to back-analyze geotechnical parameters for design, evaluate the potential failure envelope, and facilitate conceptualization of remediation options. The slope stability analysis was carried out and the methodology of Morgenstern-Price was used in determination of the factors of safety. The selected two-dimensional section was analyzed assuming that the shear strengths of the materials along the potential failure surface are governed by linear (Mohr-Coulomb) relationships between shear strength and the normal stress on the failure surface. By assuming a factor of safety of 1.0

for a slope that is known to have failed, shear strength parameters for the slide mass can be back-calculated for use in the design of stabilization measures.
