DEVIATIONS FROM DESIGN IMPACT PERFORMANCE OF AN AGGREGATE PIER SUPPORTED EMBANKMENT

Jay L. Hodkinson , GZA GeoEnvironmental, Inc., Manchester, NH, USA
James R. Wheeler, Design/Build Geotechnical, LLC, Marlborough, MA, USA
Christopher C. Benda, Vermont Agency of Transportation, Montpelier, VT, USA

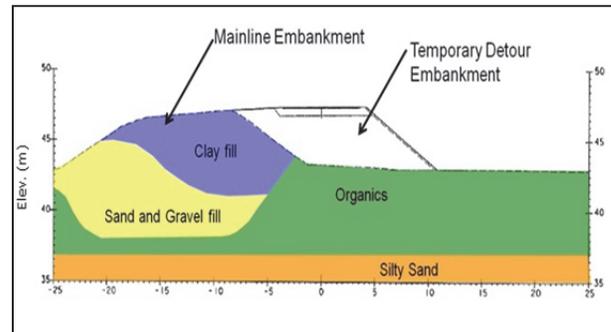
Figure 3 – South Detour Approach Abutment

At the south abutments, subsurface conditions consisted generally of fill or organic soils underlain by silty clay or alternating silt and sand layers. Fill material encountered included an upper clay fill assumed to have been placed during the widening of the embankment in 1936 and a lower granular fill that was likely placed during the construction of the original embankment. The organic soils were highly compressible with a high organic content ranging from 22.5% to 35%. The underlying clay stratum had intermittent sand seams and a plasticity index of 25. A sand and silt stratum consisting of alternating layers of silty sand and silt was encountered below the organic or clay stratum. A cross section of the south embankment section is shown in Figure 3.

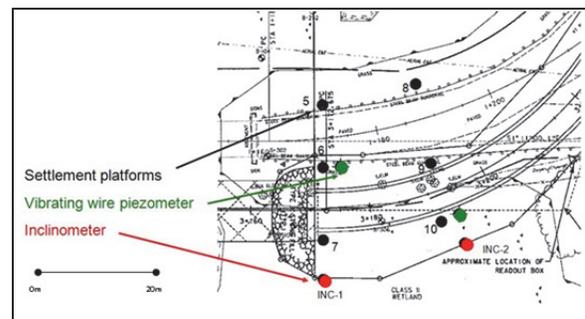
Figure 4 – Instrumentation Plan

As shown on the timeline in Table 2, the general contractor mobilized to the site and retained a third party geotechnical consultant as required to install piezometers and inclinometers at the locations shown in Figure 4.
