Slope Rehabilitation at the Baltimore-Washington Parkway Using Rammed Aggregate Piers

**Transportation Research Board
83rd Annual Meeting
January, 2004
Washington, D.C.**

E. O'Malley¹, S. Saunders², and J. Ecker³

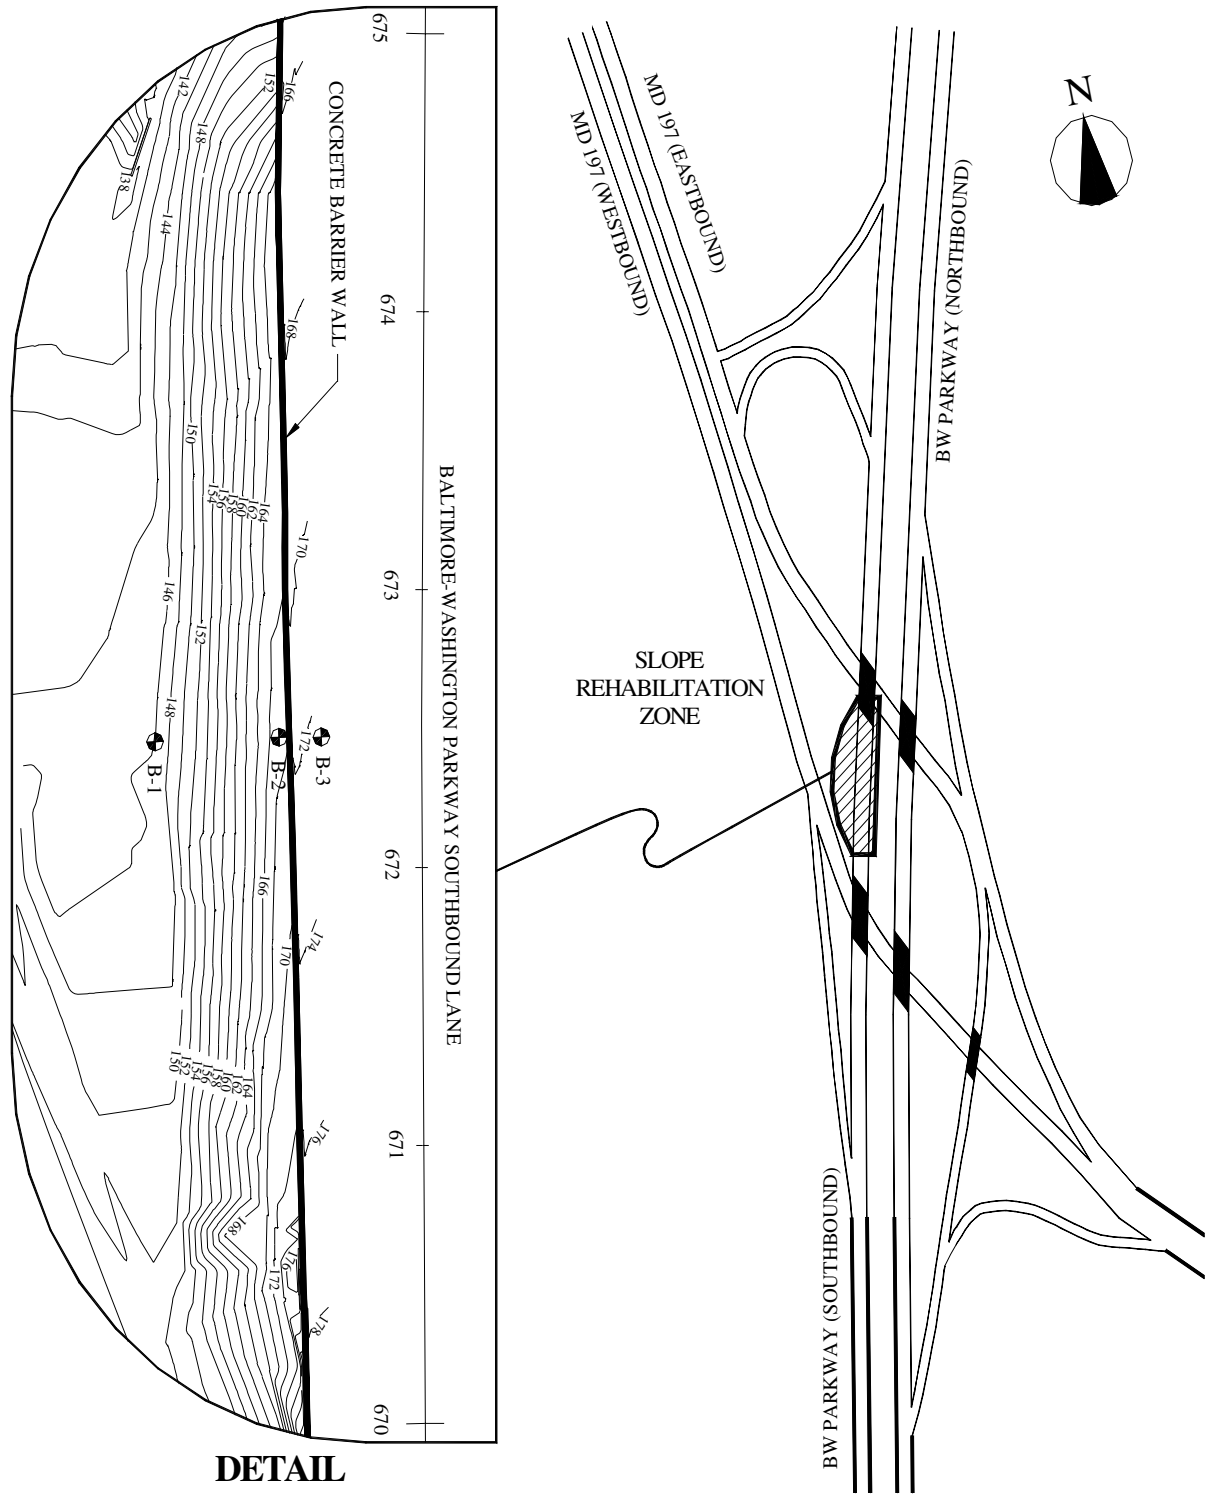
A geotechnical investigation was performed under the supervision of the FHWA to investigate subsurface conditions in the area of the failed slope and to provide geotechnical data for the design of the repair. The investigation included drilling three soil borings at locations shown in Figure 2; conducting direct shear, moisture content, and Atterberg Limits testing; and installing a slope inclinometer to define the depth of the failure surface. No obvious toe bulging of the slope was observed during several site inspections. Although the slope surface was soft and wet in some areas, no free ground water was observed in the borings.

FIGURE 2. Pre-construction site plan

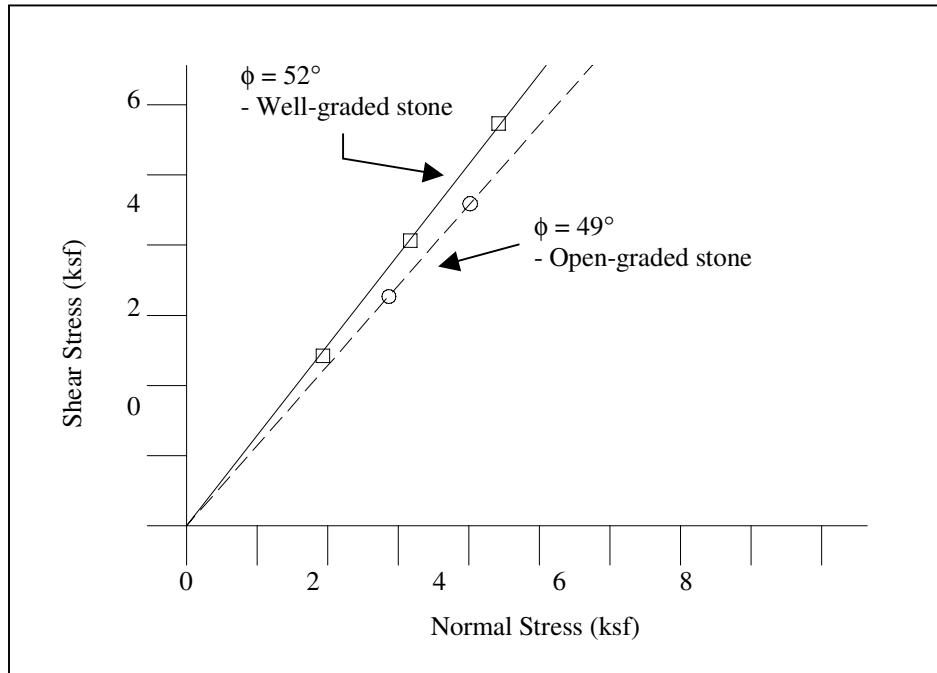
The shear strength of the rammed aggregate pier material has been determined from the results of full-scale direct shear tests performed on rammed aggregate pier elements at a project site near Atlanta, Georgia (Fox and Cowell, 1998) and by triaxial tests performed at Iowa State University (White, 2001). Test results, shown in Figures 9 and 10, respectively, indicate a friction angle of about 48 degrees for piers constructed from manufactured open-graded stone (no fines) and a friction angle of about 52 degrees for piers constructed from manufactured graded aggregate base material (5 to 10 percent fines) consisting of recycled concrete. A friction angle of 44 degrees was used for the recycled concrete material to be used to construct the rammed aggregate pier shafts. The 44-degree friction angle for recycled concrete was determined by testing performed at Iowa State University (White, et al., 2002).

FIGURE 9. Results of in-situ direct shear tests on rammed aggregate piers

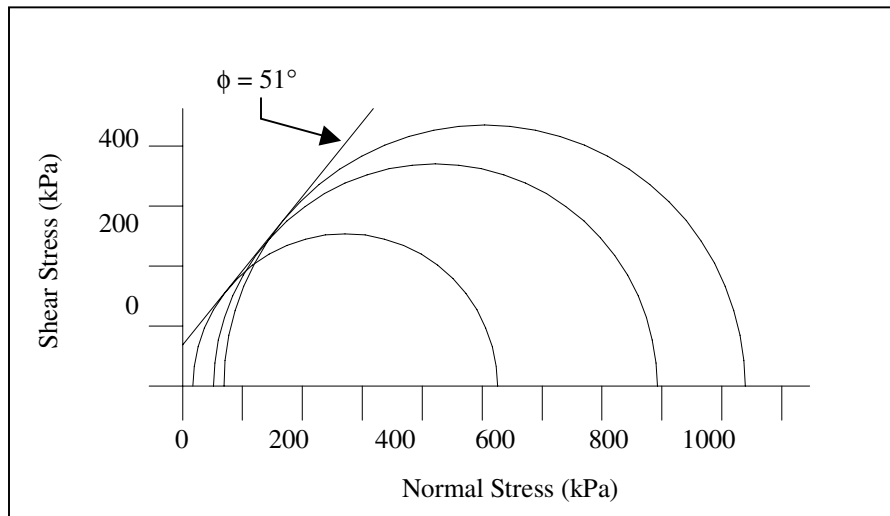
FIGURE 10. Results of triaxial shearing tests performed on reconstituted samples of rammed aggregate pier material

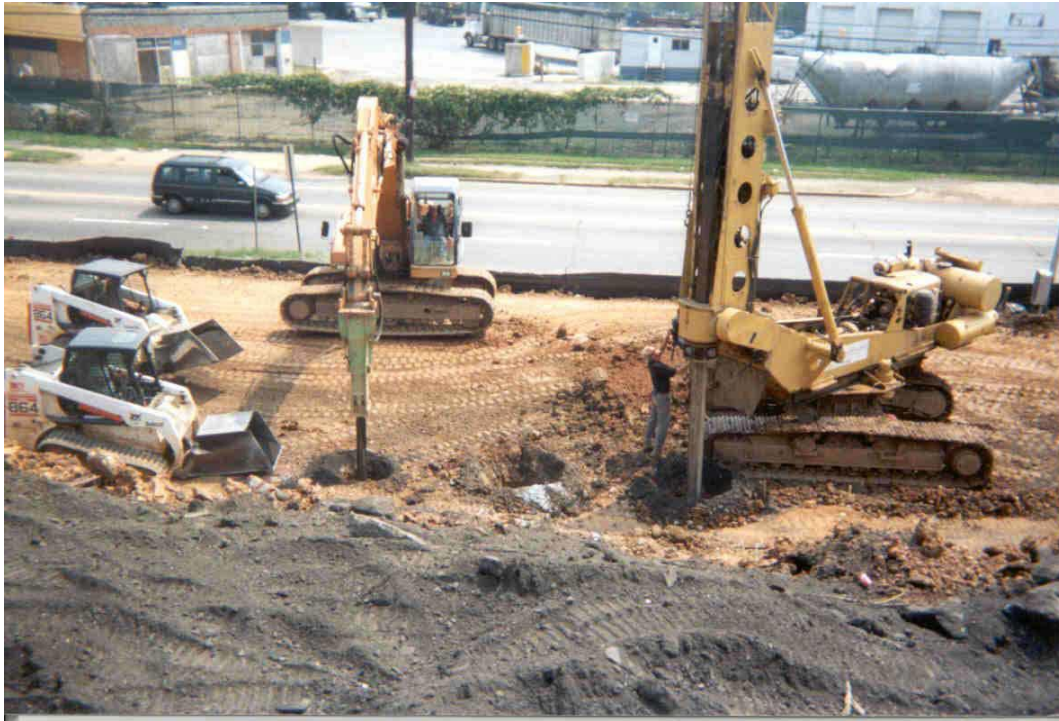
FIGURE 12. Rammed aggregate pier construction

The construction of rammed aggregate piers is described in the literature (Lawton and Fox, 1994; Lawton, et al., 1994; Wissmann and Fox, 2000; Wissmann, et al., 2000; Wissmann, et al., 2001; Minks, et al., 2001) and shown in Figure 12. A total of 472 rammed aggregate piers for slope stabilization were installed by drilling 760 mm (30 inch) diameter holes to depths ranging between 3 and 6.5 m (10 and 21 feet), placing controlled lifts of aggregate within the cavities, and compacting the aggregate using a specially designed high-energy beveled impact tamper. The first lift consisted of clean stone and was rammed into the soil to form a bottom bulb below the excavated shaft. The piers were completed by placing additional 0.3-m (one-foot) thick lifts of aggregate over the bottom bulb and compacting the aggregate with the beveled tamper. During densification, the beveled shape of the tamper forces aggregate laterally into the sidewall of the excavated cavity. This action increases the lateral stress in the matrix soil thus providing additional stiffening and increased normal stress perpendicular to the perimeter shearing surface.
