## State Road P48 Landslide Stabilization Dallas County, Iowa

**Description:** Grading operations associated with the construction of State Road P48 coupled with high groundwater and a weak soil/shale zone resulted in a problematic landslide condition.

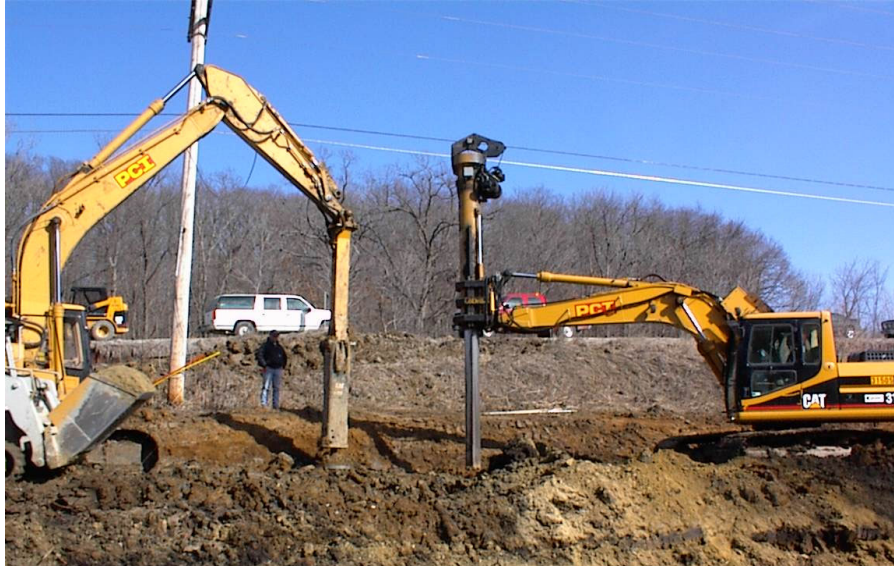
**Design Details:** *Geopier*® soil reinforcing elements were installed to depths of up to 30 feet to penetrate the weak shale zone and intersect the critical shearing surface. A total of 579 elements were installed to increase the factor of safety and prevent further movement of the slide. A 5-foot soil cap was installed in the tops of the piers to reduce the amount of groundwater infiltration through the piers. The Geopier soil reinforcement solution resulted in a cost of \$170,000 representing a cost savings of over \$700,000 compared to other options being considered.
