Target Store Landslide Stabilization Raleigh, North Carolina

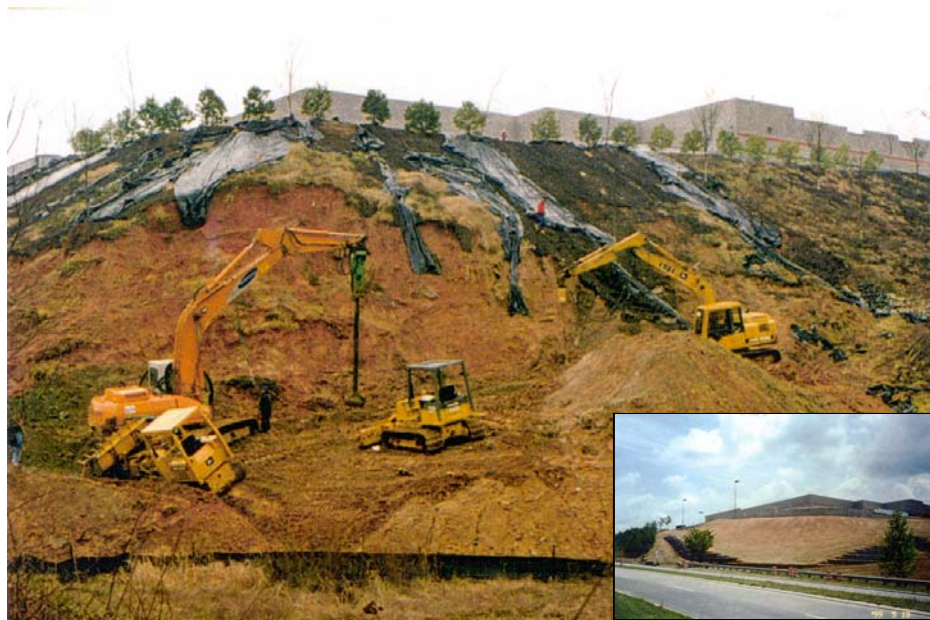
Description: The fill slope that was up to 65 feet high with slope angles ranging from 27 to 34 degrees. The landslide encroached on a large commercial superstore at the crest and a roadway at the toe.

Design Details: A solution, consisting of *Geopier*[®] soil reinforcement installed to intersect the slope failure plane, and supporting a gabion-faced MSE wall as a toe buttress combined with a low H-pile and concrete lagging wall at the crest of the 2.5(H): 1(V) slope was accepted. This solution replaced the conventional solution of excavating and backfilling the buttress. The *Geopier* construction eliminated the need for staged construction, shoring and significant overexcavation.
